**KARANG AMPEL - CIREBON
ROAD SAFETY AUDIT REPORT
As Constructed**

THE PROJECT MANAGEMENT UNIT
STRATEGIC ROADS INFRASTRUCTURE PROJECT
Under IBRD Loan 4834 / 7786 ID

PACKAGE KARANG AMPEL - CIREBON ROAD SAFETY AUDIT REPORT Existing Road Stage - As Constructed June 2010

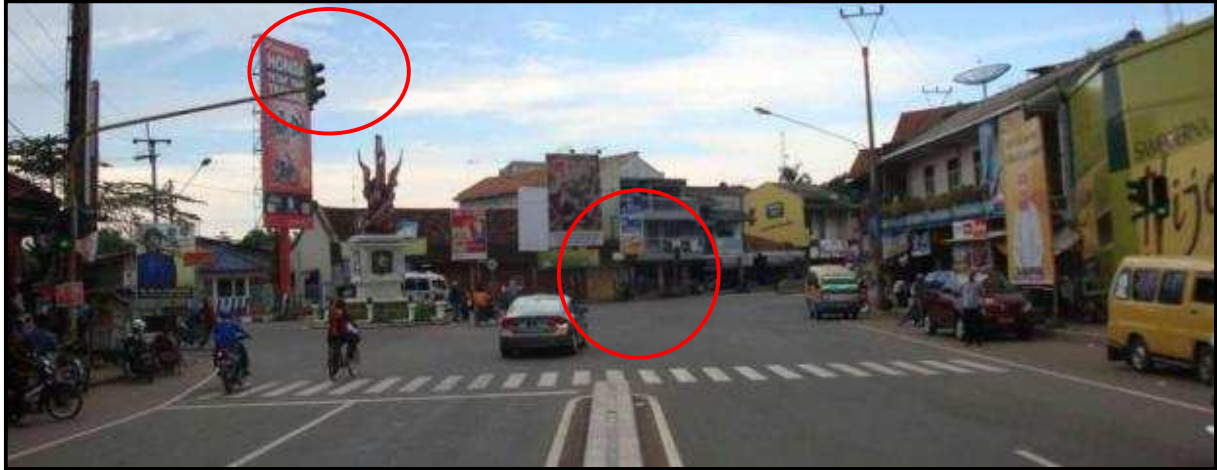
The proposed design included new signal equipment, islands, footways, pedestrian barriers, but this was not implemented. The junction is still very unsafe for pedestrians and much of the signal equipment is not working or damaged, see photos below:

The Traffic Signal Junction Has Not been Improved as Described in Drawings

- Add rumble bars to all approaches
- Ensure all broken signal equipment repaired promptly
- Upgrade main signal head on each approach to large high visibility specification

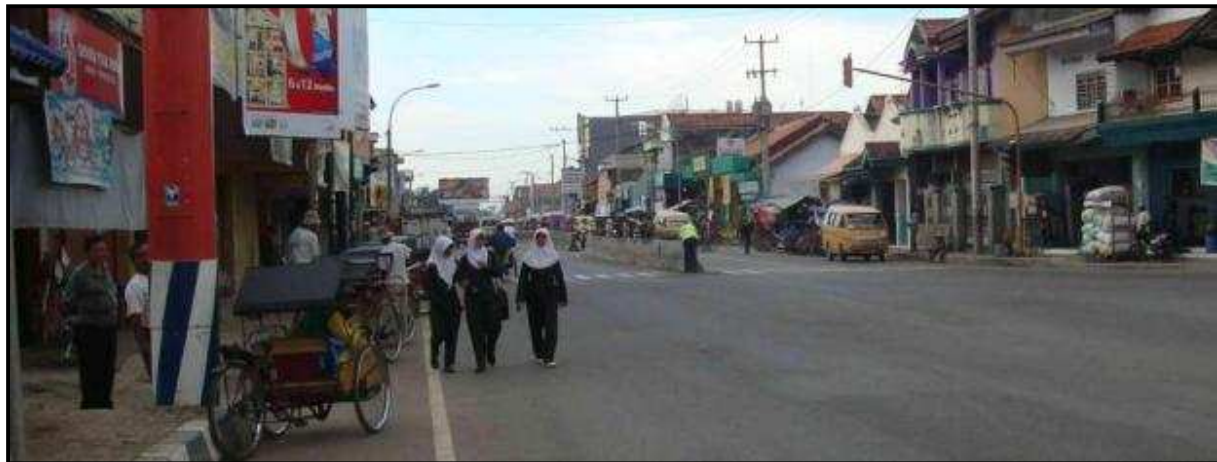
Shoulders & Pedestrian Paths are Used for Parking by Becak & Public Transport

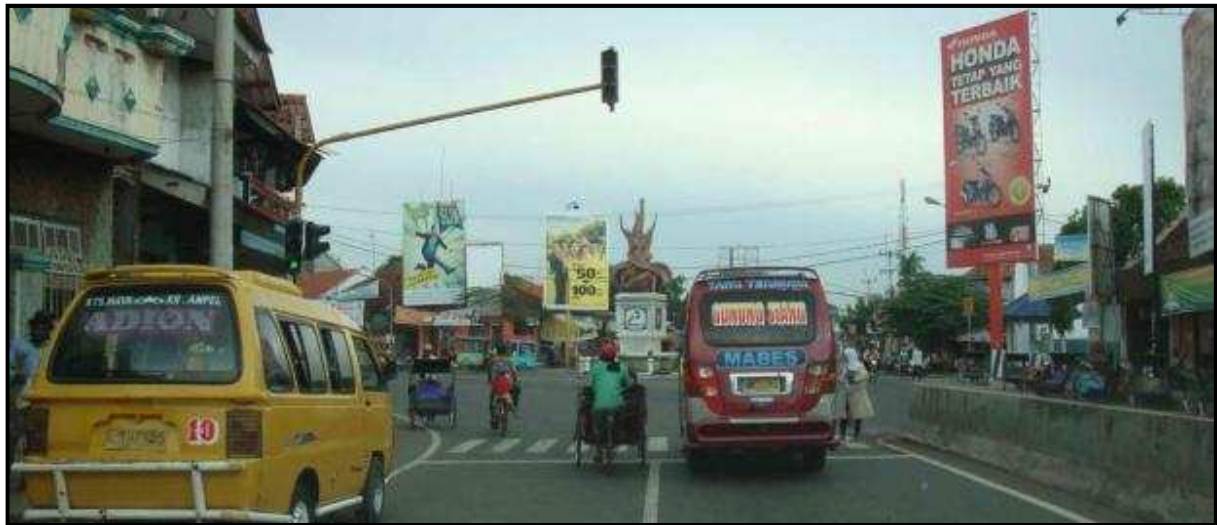
Junction is Un-Safe for Pedestrians & All Road Users

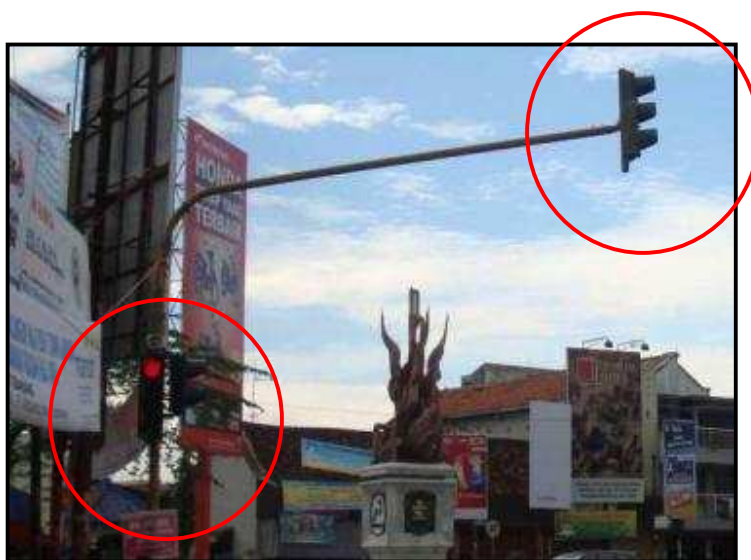
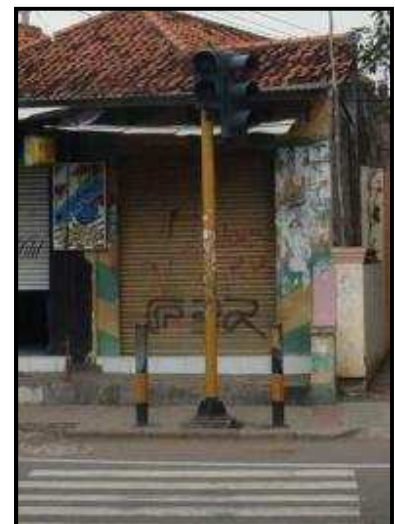
Poor Condition of Traffic Signals (Damaged and Broken) and Pedestrian Crossing Blocked by the Poles

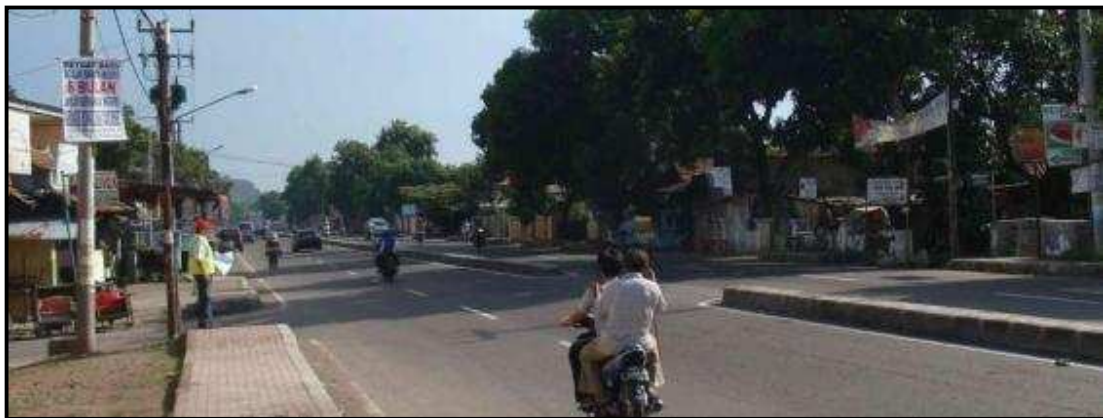
Junction at Sta 27+000 Still Un signalized

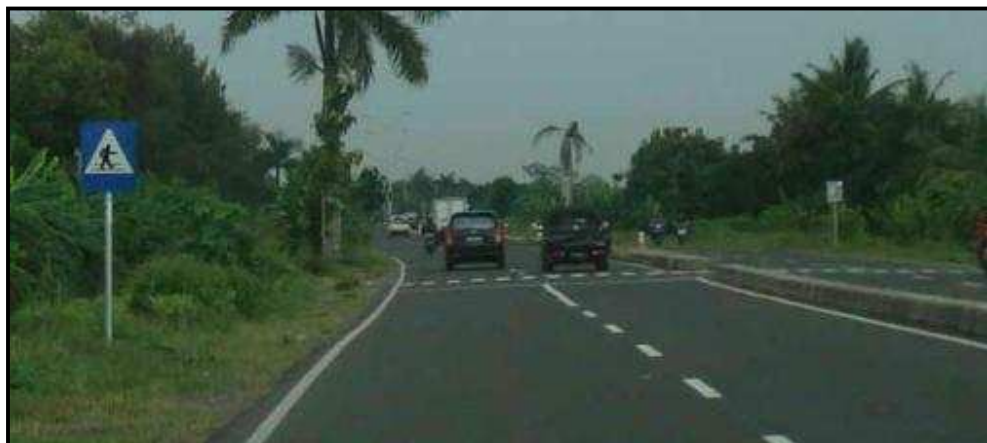
Road signs are not at proper location, should be 100 up to 50 meter from pedestrian crossing, See below

- All traffic sign should be reviewed and detailed shop drawing produced to show all signs need to be installed and their exact location on large scale plans.
- Avoid placing traffic sign on narrow median, blocking footpaths, hiding signals or hidden by trees

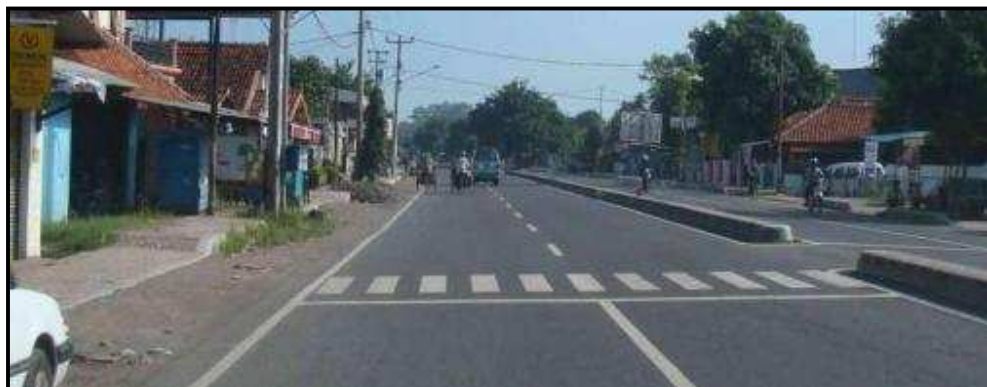
No advance warning at U Turn, Pedestrian crossing and put the pedestrian in danger

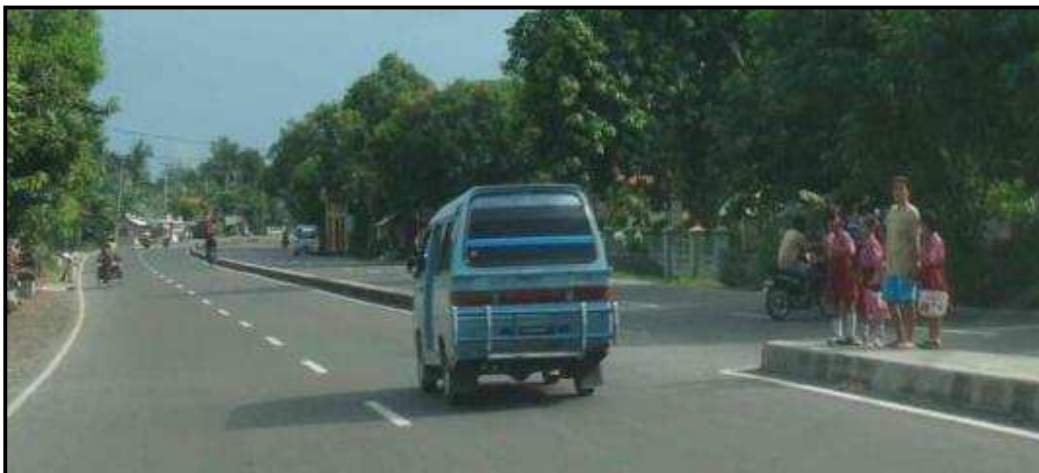
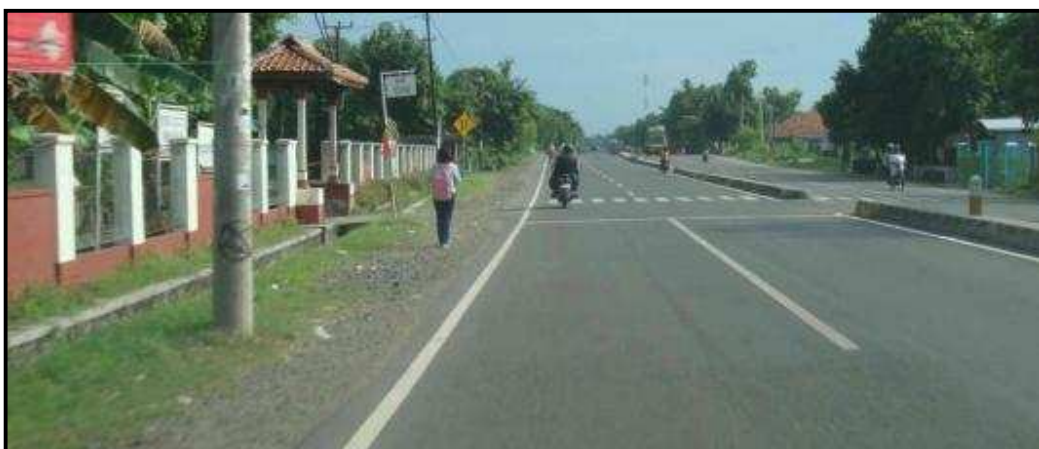
There are many gaps in median are likely to result in serious accident patterns. The U turns do not have a taper and all have narrow median.

And all gaps in median lack highly visible advance warning signing and there are no speed reduction measure. As shown below;

- Improve signing at all U turns
- Add rumble bars in advance of all gaps
- Paint curbs with high quality reflective paint at all gaps

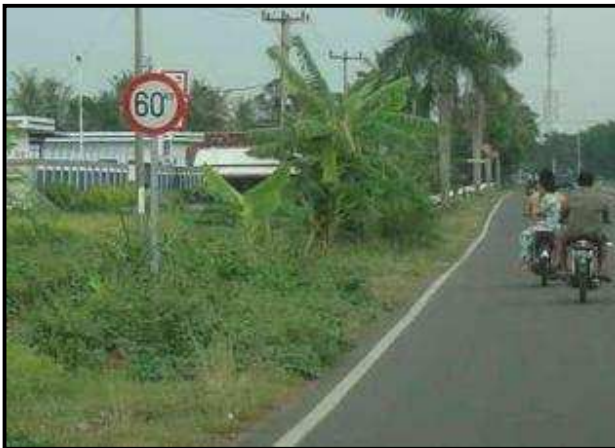
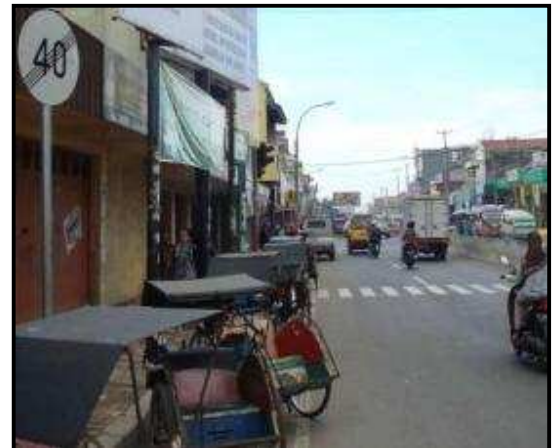
- there is a great lack of speed limit signs throughout the project. See few isolated signs below.
- Incorrect speed limit approaching School

- Review the whole length of the project and use an appropriate speed limits at commercial areas etc.
- Ensure reduce speed limit are installed on school zone.

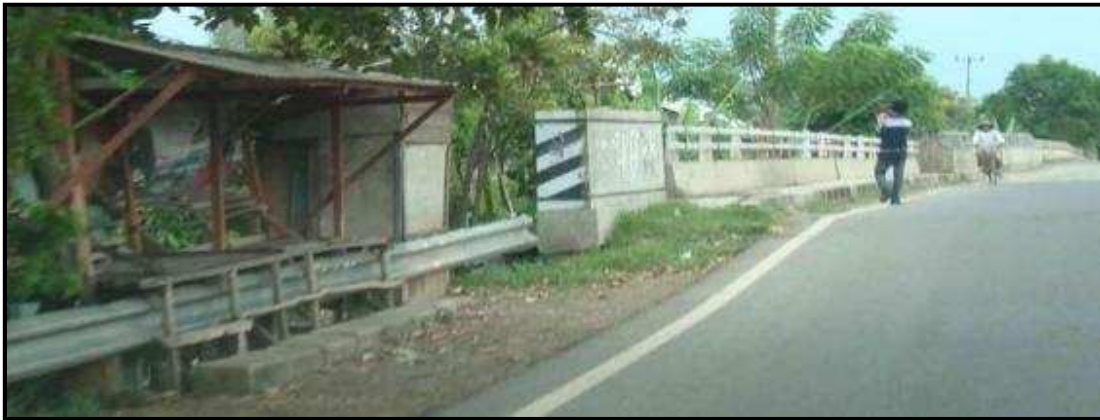
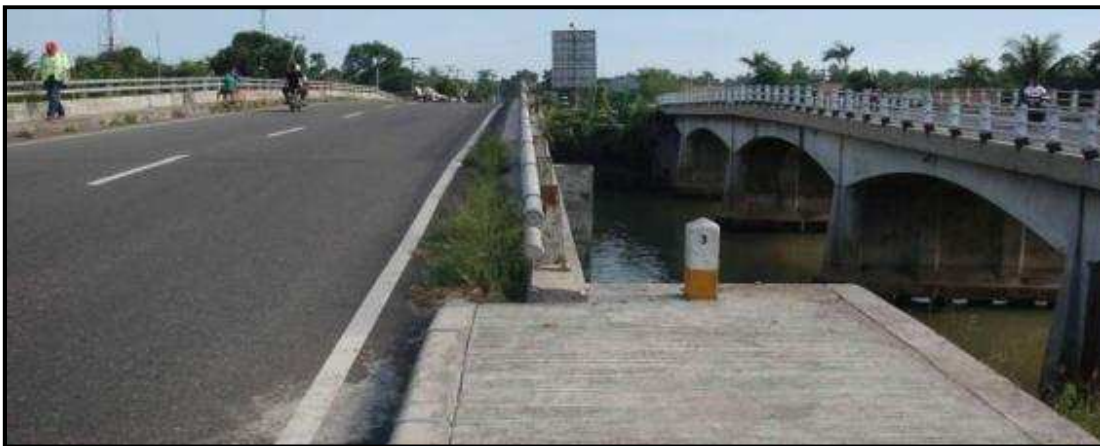
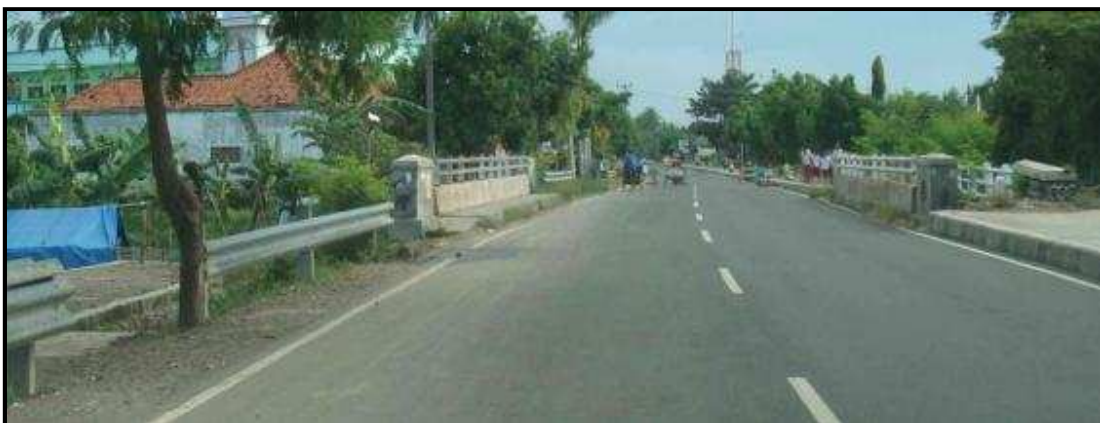
There are many lengths of guard rail installed, but they do not all follow standard drawings and they are poorly connected to bridges. There is also lack of maintenance for damaged rails, see photos examples below:

- Review all guard rail installations & maintenance procedures
- Repair all damaged rails as a matter of urgency
- There should be no exposed end of guard rails
- There should be a strong connection between flexible guard rail and a rigid bridge parapet, see high standard example below:

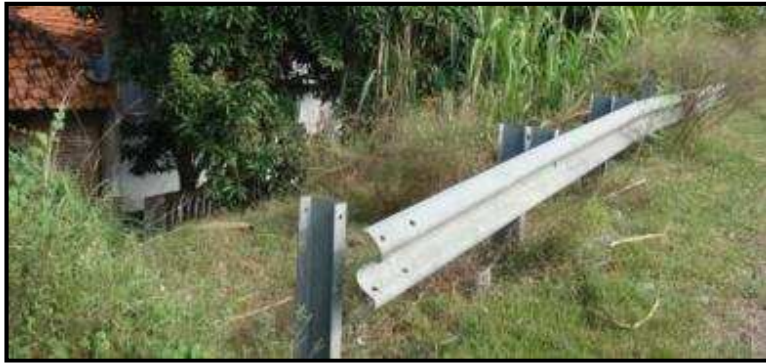
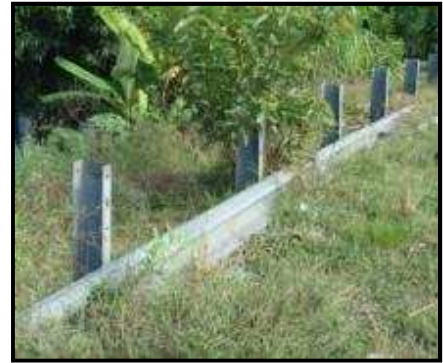
Broken Guardrail and No Maintenance

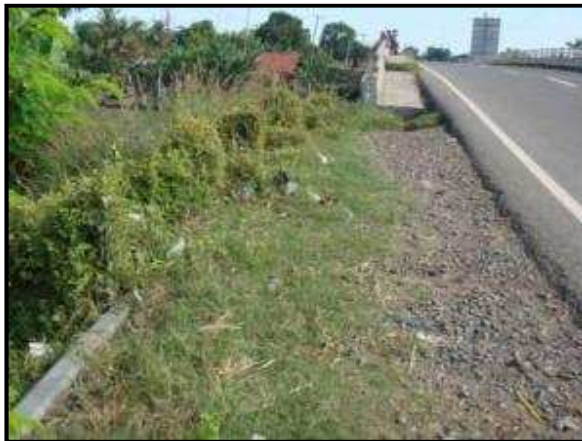
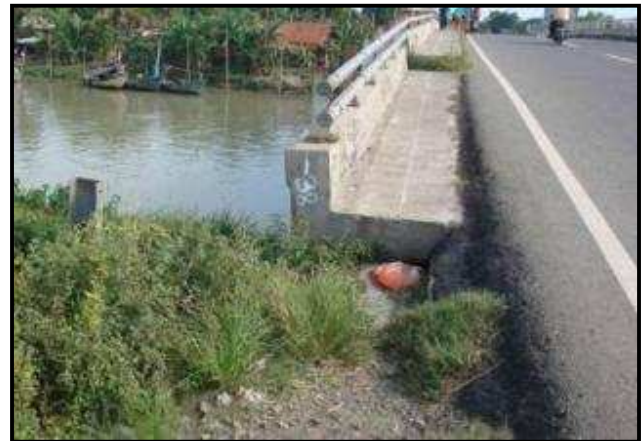
No Bridge Protection, and Hazardous to Road Users

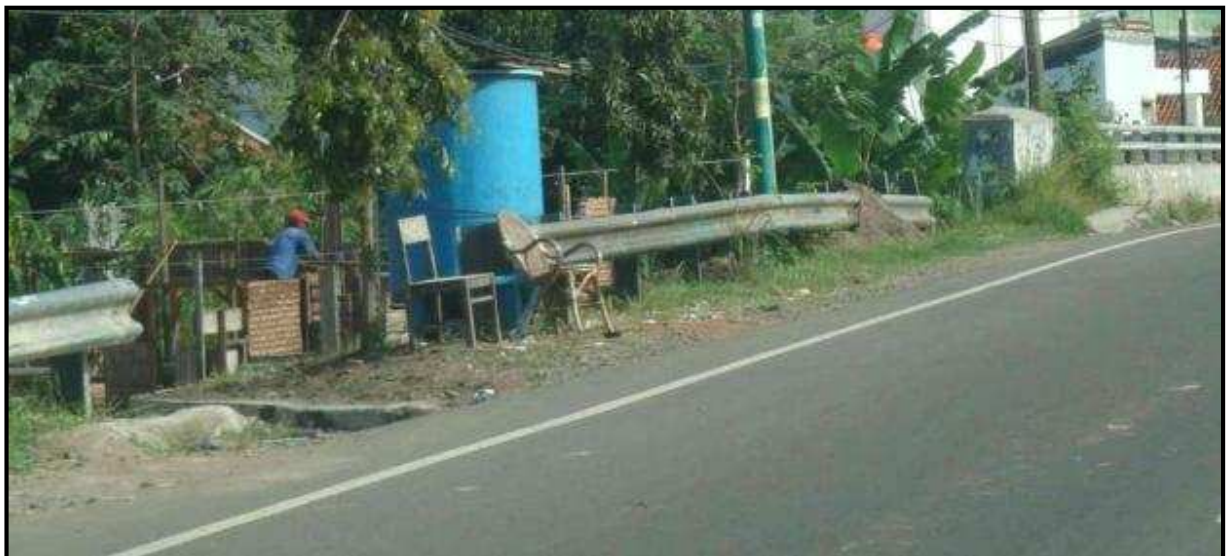
Broken Guard Rail by Local People for Their Access Road

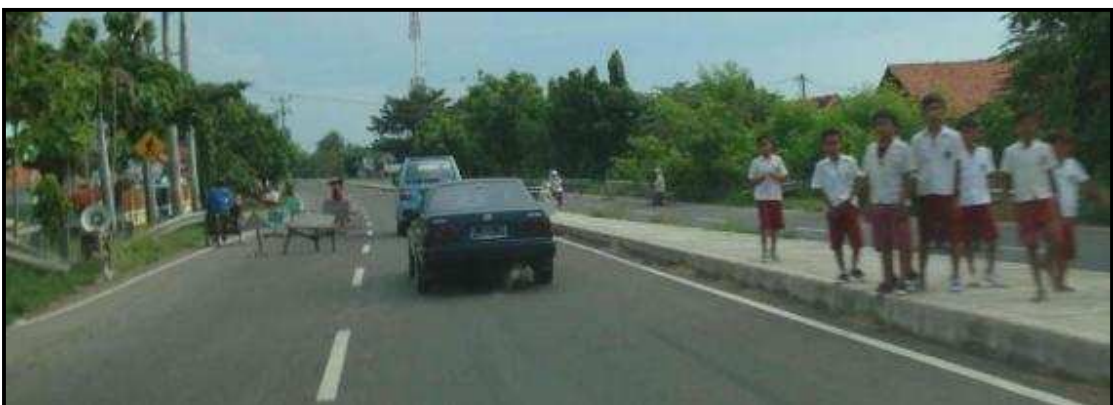
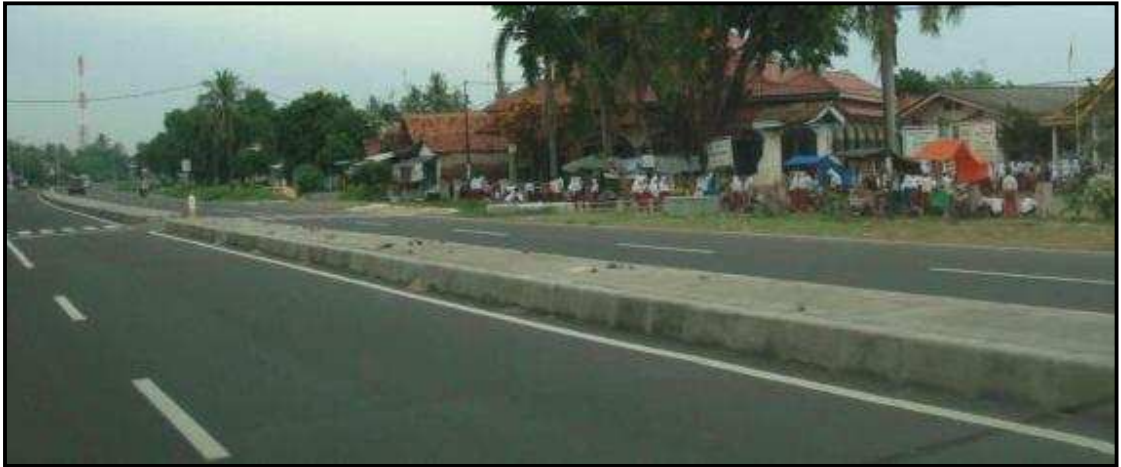
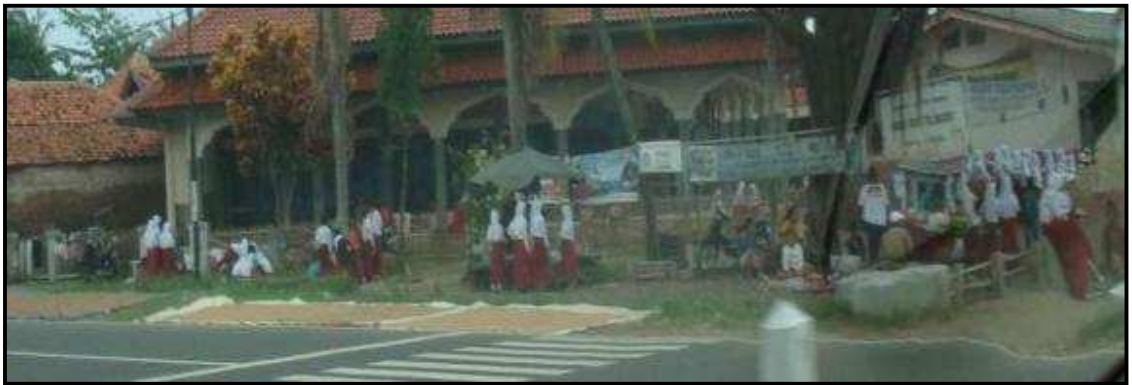
No school zones have been installed - unlike all other projects - although there are several locations where hundreds of pupils have to cross the dual carriageway, see photos below.

- Urgent consideration needs to be given to adding standard school zone markings, speed limits rumble bars etc. at all schools, see standard details below:

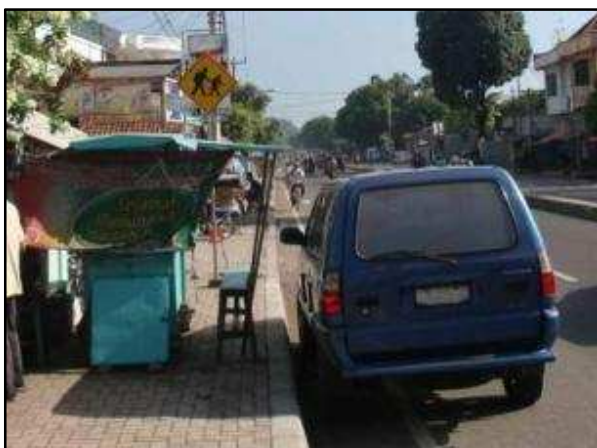
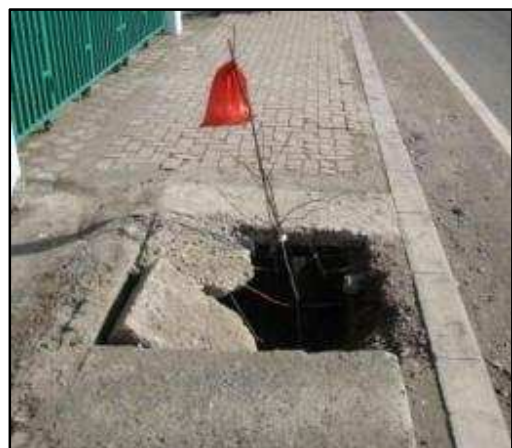
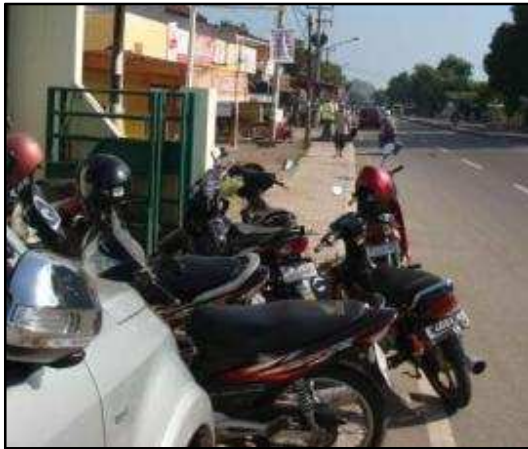
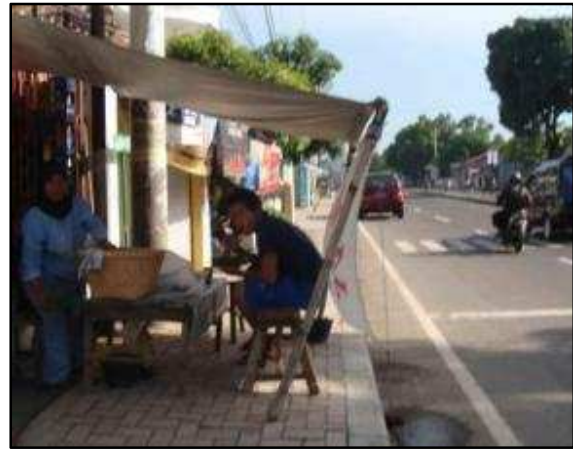
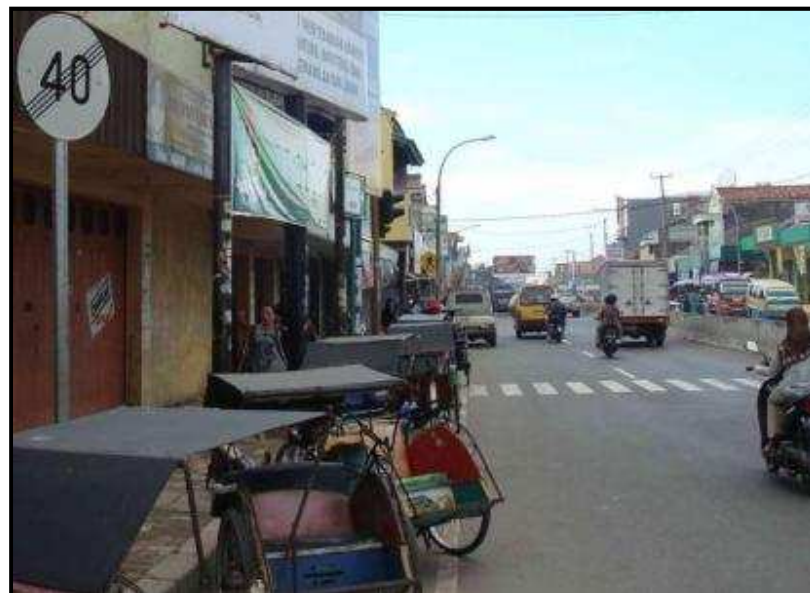
There are many safety hazards for pedestrians on the project with blocked or damaged footways, and there are no traffic calming measures at the crossings.

- **Review all footways and pedestrian crossings on the road project**
- **Clear blockages on pedestrian footpaths**
- **Review maintenance of footways and repair all defects**
- **Add traffic calming such as rumble strips, speed limits or flashers at crossings**

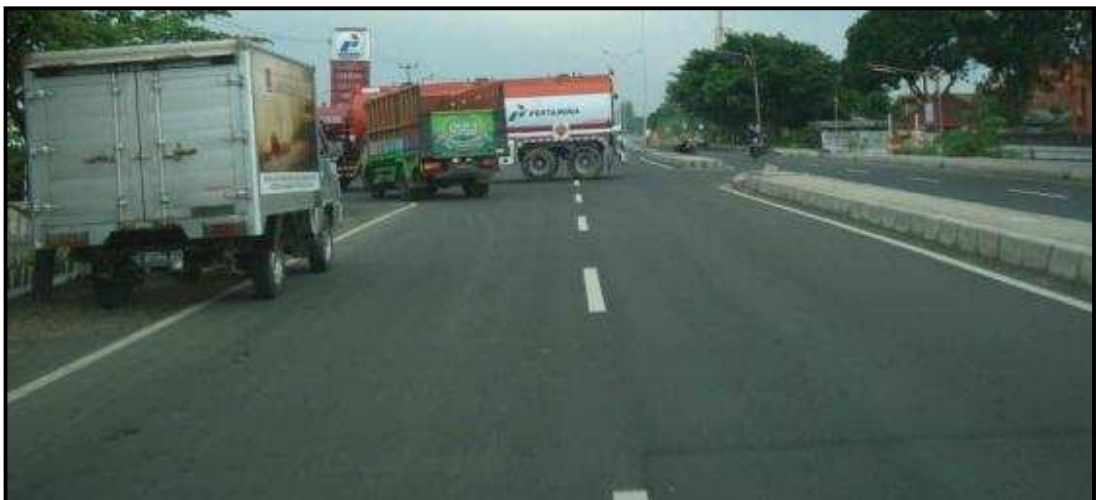
Many Vehicles are parked at the shoulder on the project, causing sudden braking or nose-to-tail shunts and also blocking visibility for any road user;

Similar problems are caused by buses picking up or dropping their passengers

Little or no effort has been made to design parking or waiting areas or bus stops. In consequence the road is blocked congested and dangerous at busy locations.

- **Review need for bus stops, parking and loading areas and design and install appropriate facilities**

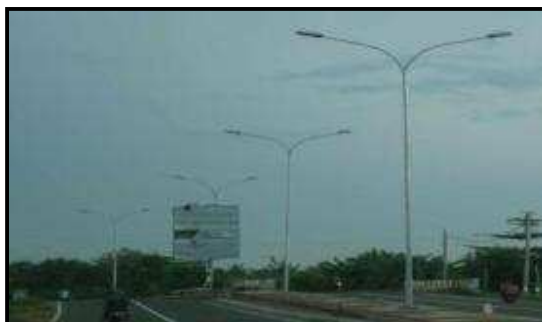
Street lights had been installed but were not working and no new lightning at intersections.

- **Ensure all street lighting is working correctly and repair and maintenance procedures adequate**
- **Review need to increase lighting at all junctions**
