**KARAWANG BYPASS
ROAD SAFETY AUDIT REPORT
As Constructed**

January 2011

THE PROJECT MANAGEMENT UNIT
STRATEGIC ROADS INFRASTRUCTURE PROJECT
Under IBRD Loan 4834 / 7786 ID

PACKAGE KARAWANG BYPASS ROAD SAFETY AUDIT REPORT As Constructed June 2010

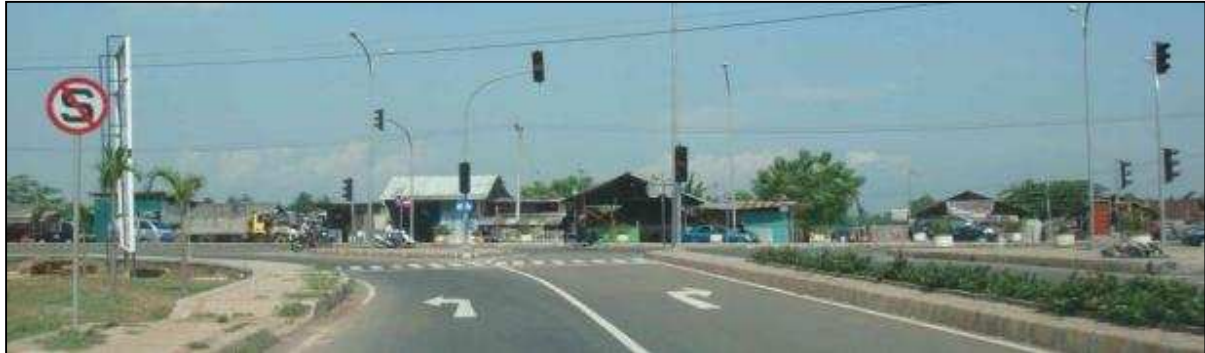
The traffic signal lamps were not working or not bright

- Add rumble bars to all approaches
- Ensure all broken signal equipment repaired promptly
- Upgrade main signal head on each approach to large high visibility specification, (see photo below)

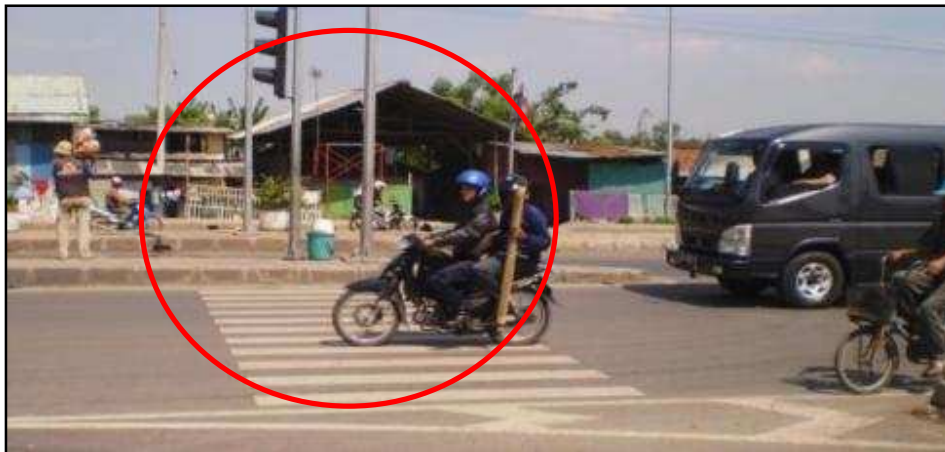
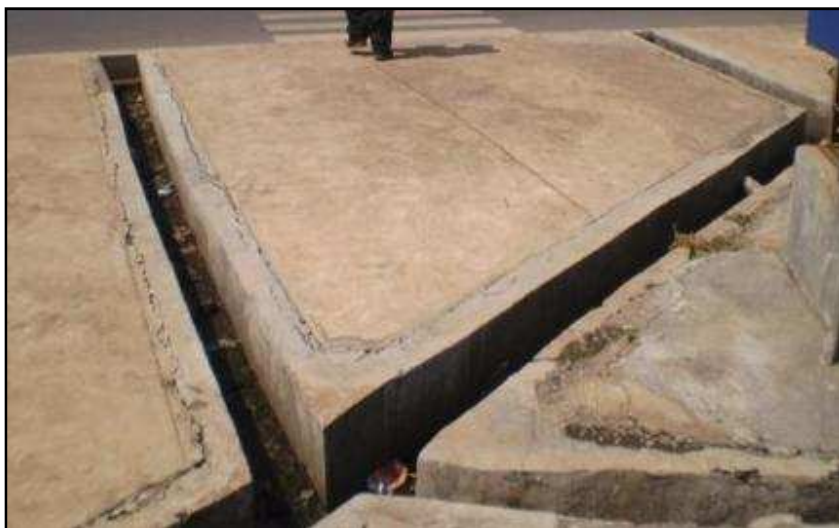
Pedestrian Crossing was blocked by Traffic Signal poles

Drainage at the Islands is exposed and hazardous to pedestrians

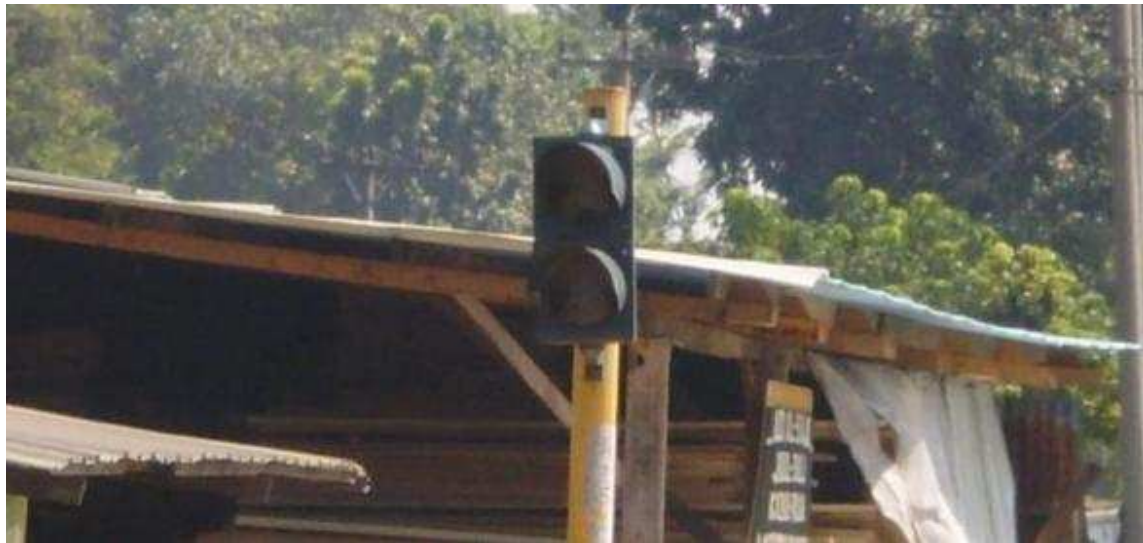
Height and size of signal head for warning light is not standard and is not working

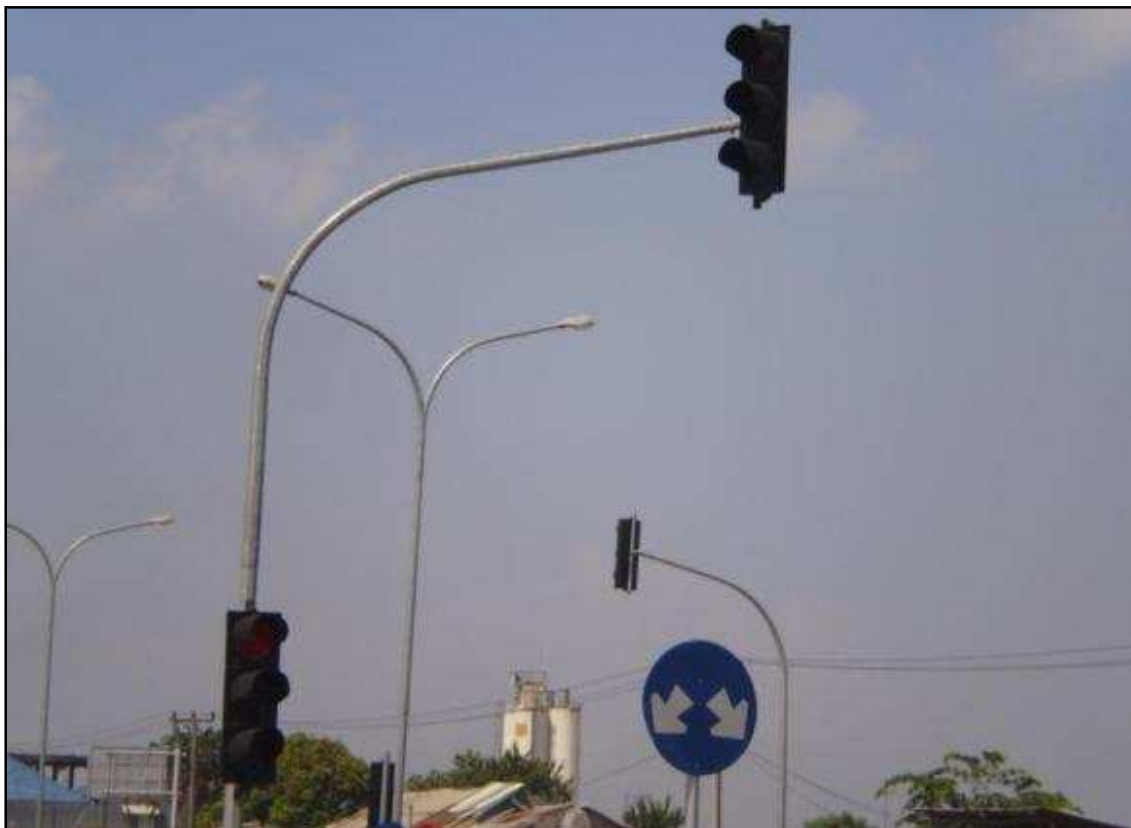
Traffic lights are not working and one pointing in wrong direction

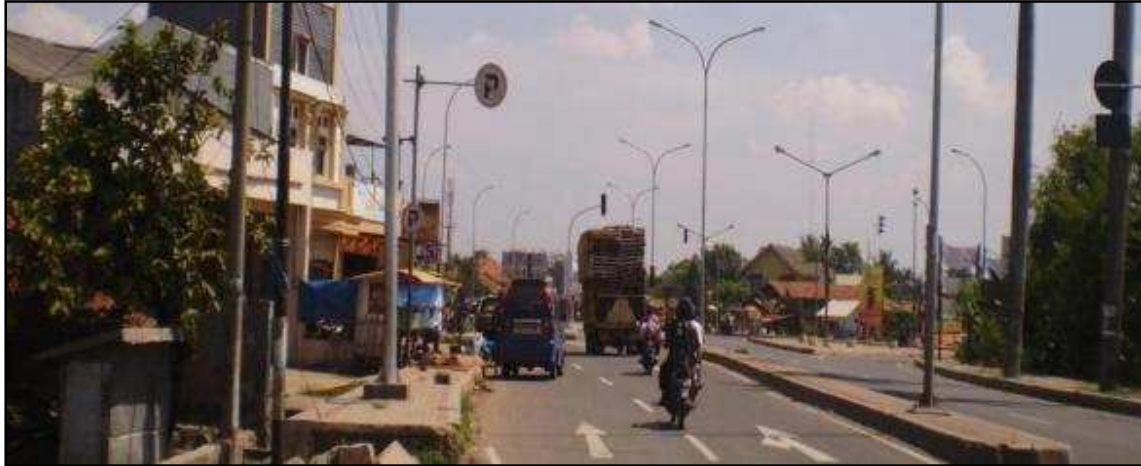
Public transport is picking up the passengers but the pedestrian paths are not constructed for safety

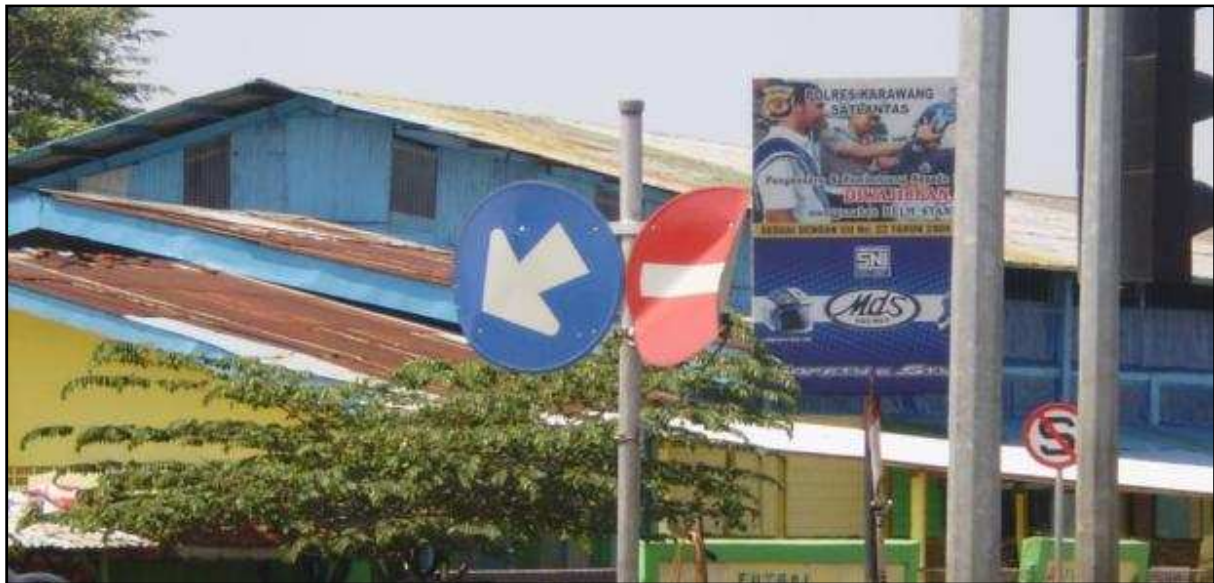
Road sign height and size are not following the standard drawing and some of the signs are damaged, as shown below;

- All traffic signs should be reviewed and damaged or non-standard ones replaced.
- Ensure signs are not blocked by trees or vegetation
- Install appropriate warning and chevron arrow signs at the sharp bend

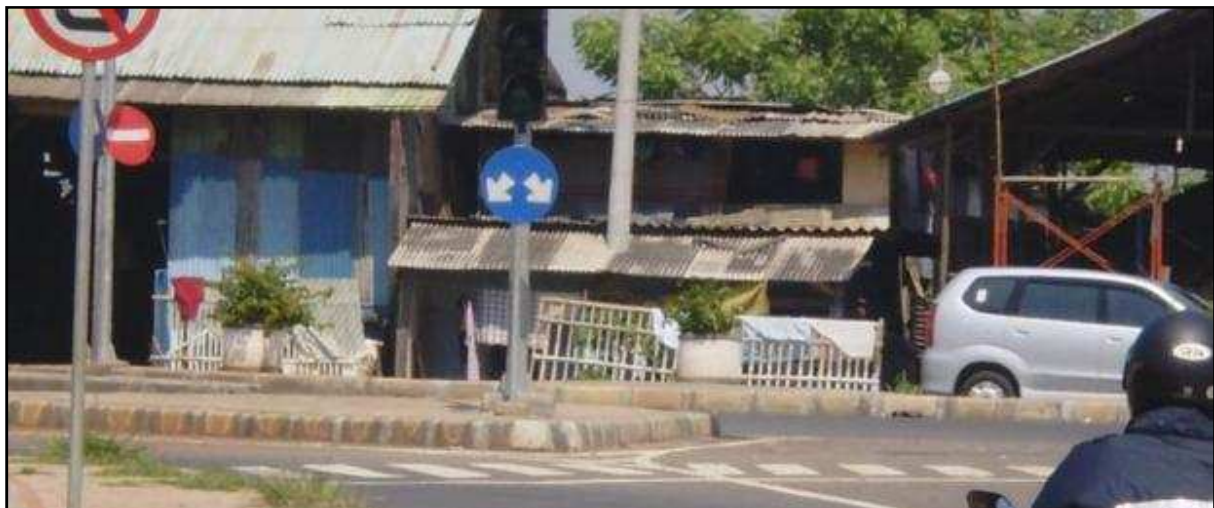
The Road sign is not standard - should be two separate arrows

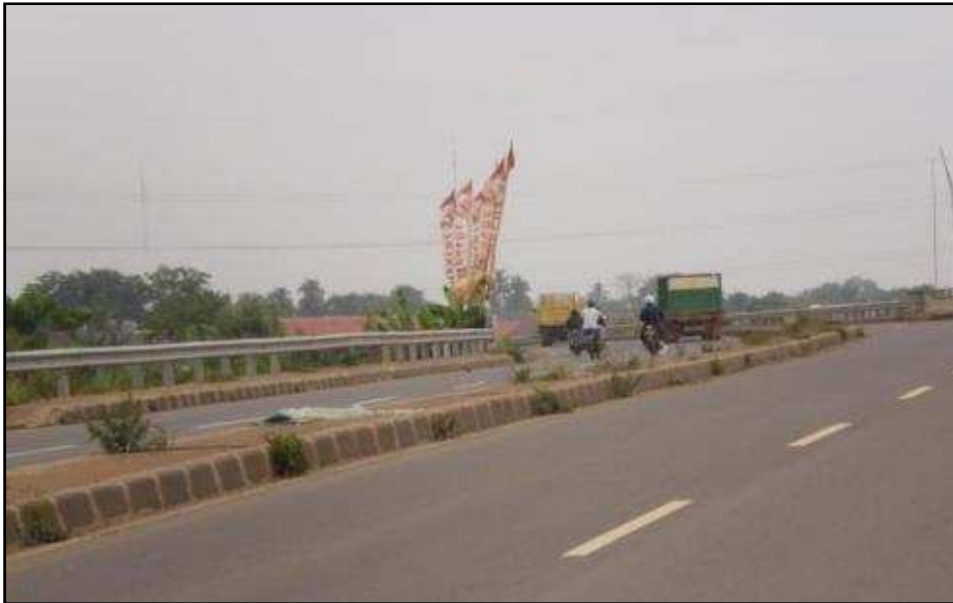
No advance warning approaching sharp bend and no arrow signs

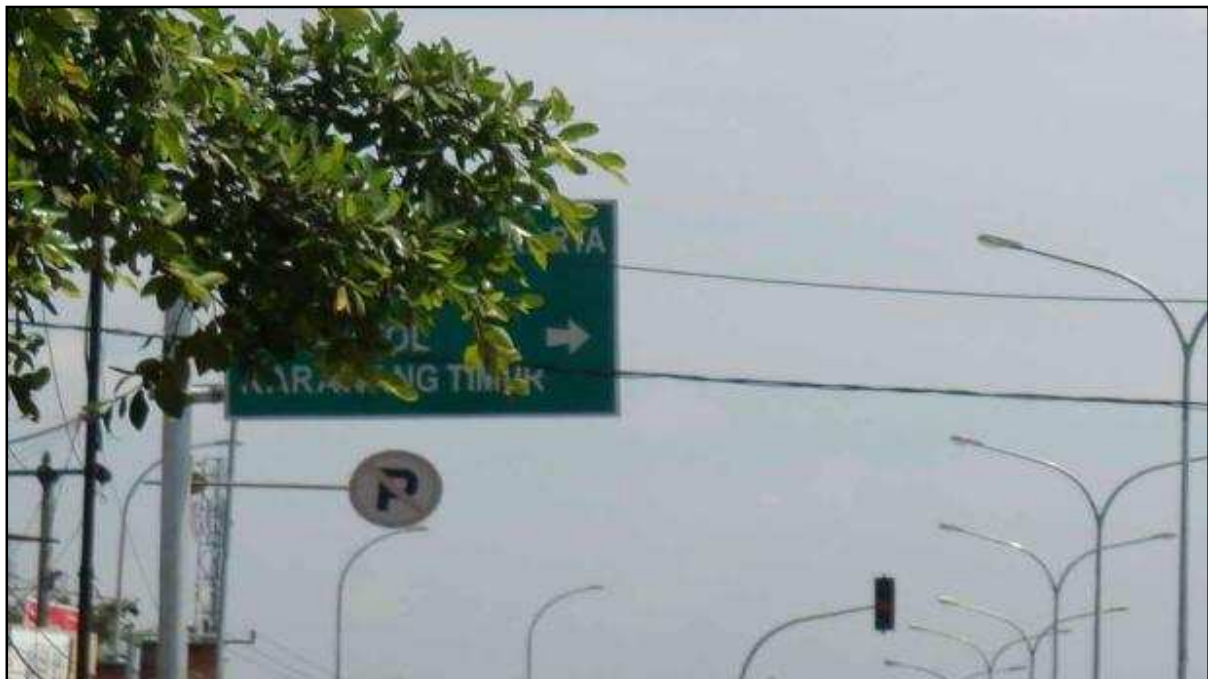
Advance direction sign hidden by tree

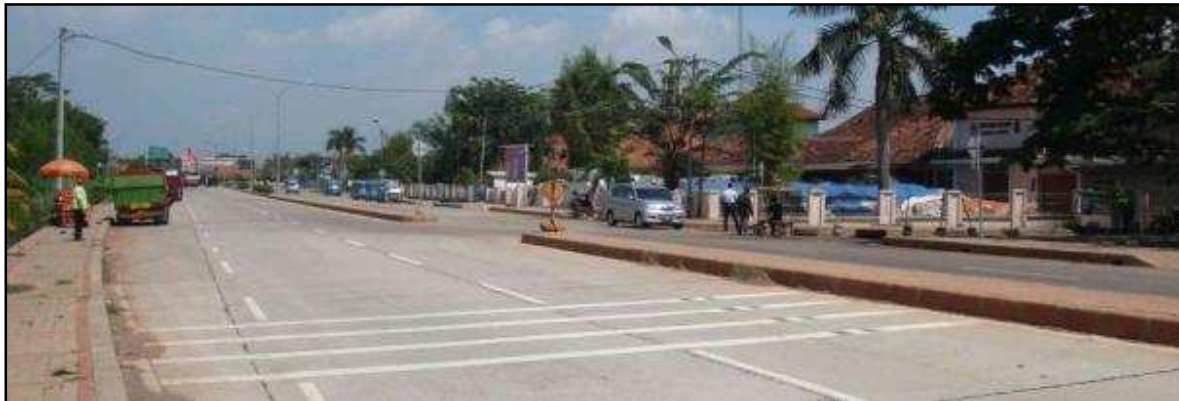
There is a gap in median at a Tee junction at Sta o+250 that is likely to result in serious accident patterns. The U turns does not have a taper and only a narrow median and is poorly signed

- **Improve the signing at gap and junction at Sta 0+250**
- **Add additional rumble bars on the approaches**

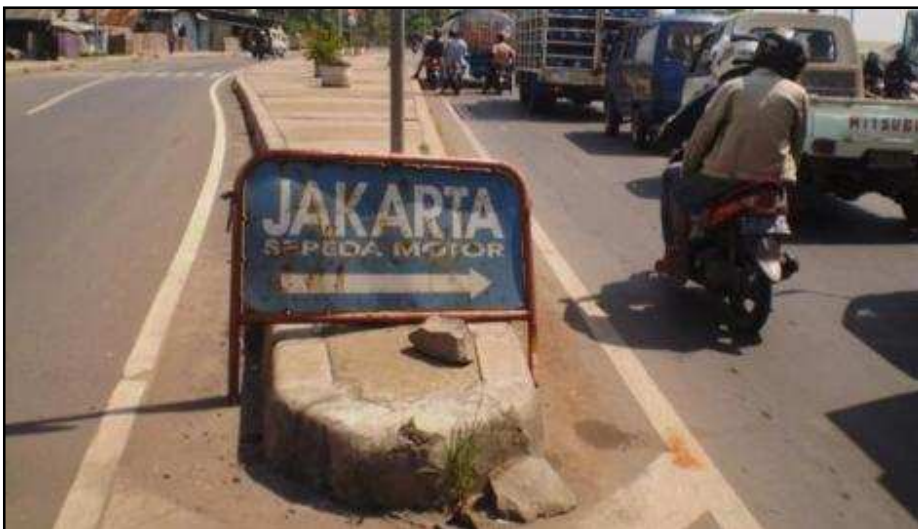
There is evidence of crashes having happened and temporary signs were placed by local people to warn the road users.

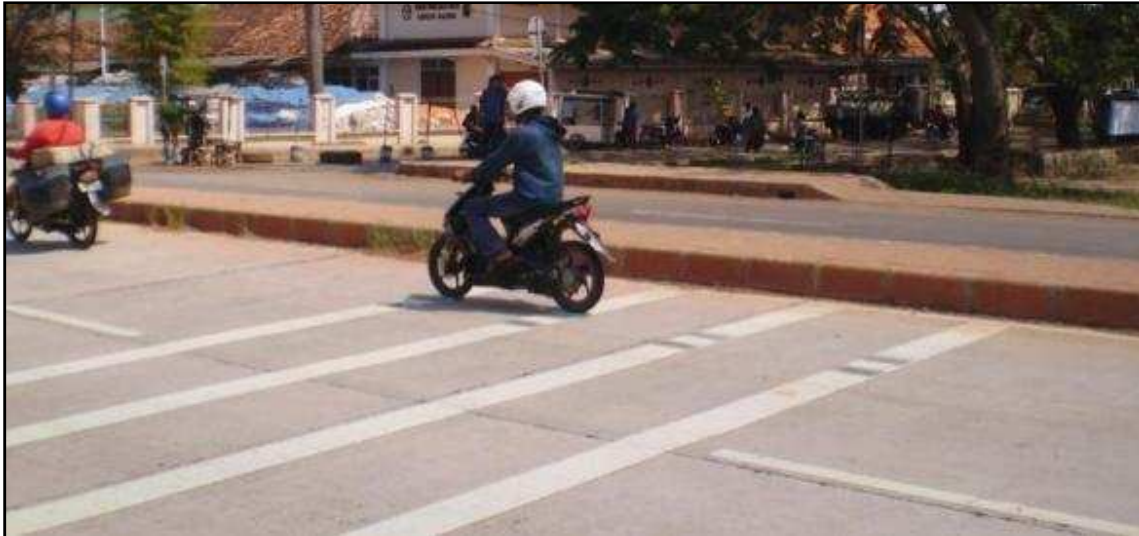
The rumble strip is too close to U Turn less than 40 meter

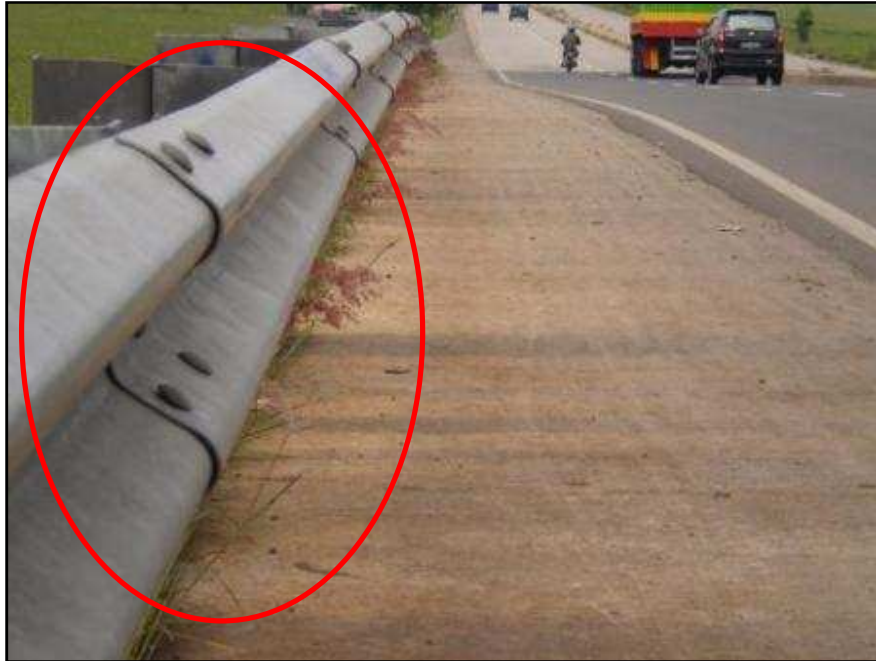
**Overlap in
wrong direction**

- **Review the need for and installation of guard rail throughout the project**
- **Install guard rail where embankments 2 m or more**
- **Where possible bury exposed end of guard rails as per the standard**
- **Look at feasibility of constructing a strong connection between flexible guard rail and the rigid parapet.**
- **Ensure overlaps correct**

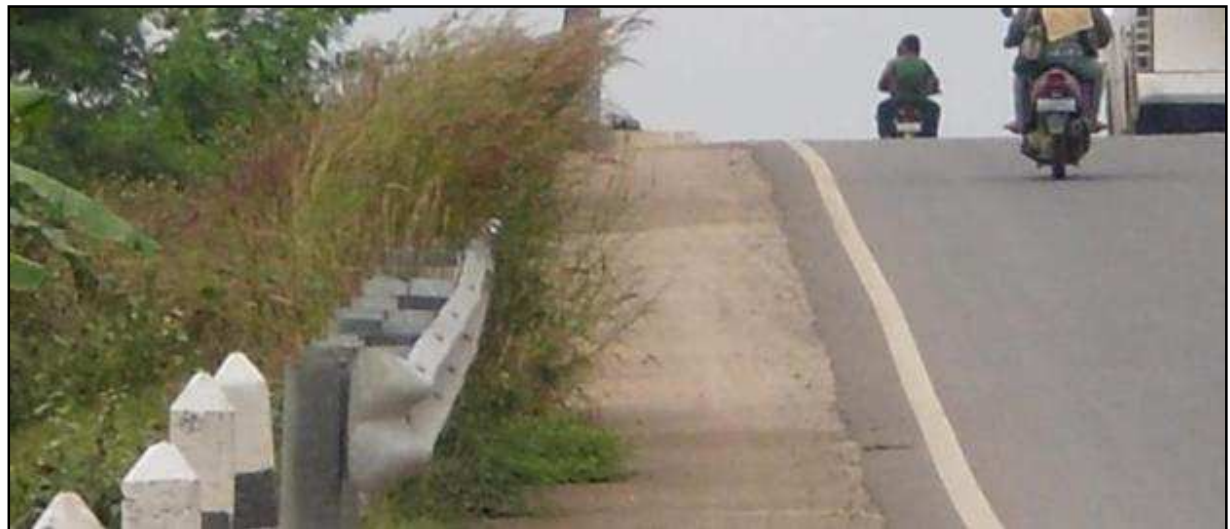
The guard rail below has exposed end, not followed the standard drawing, also no maintenance for wild bushes

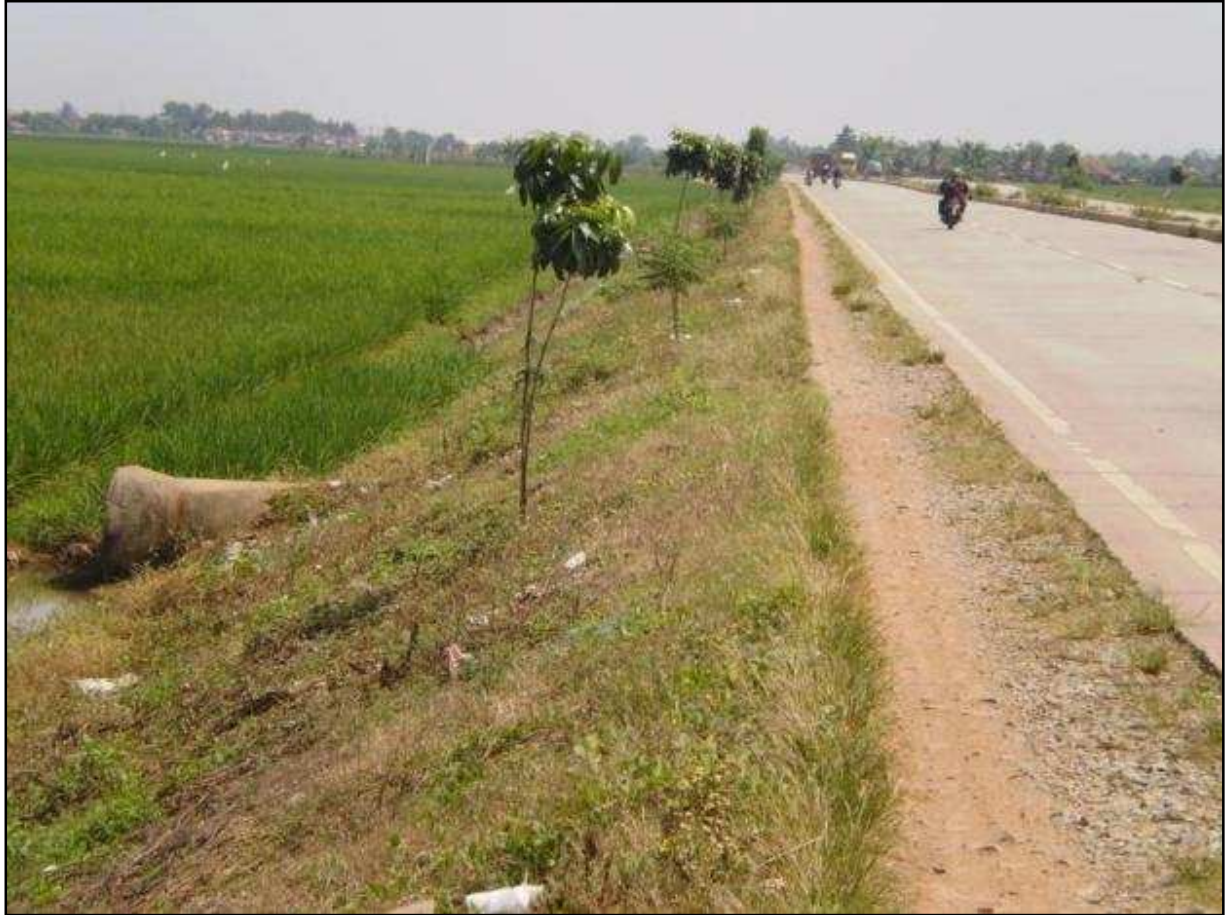
The height of the slope is greater than 2 meter. The guard rail should be installed on this condition. No protection for pipe culvert.

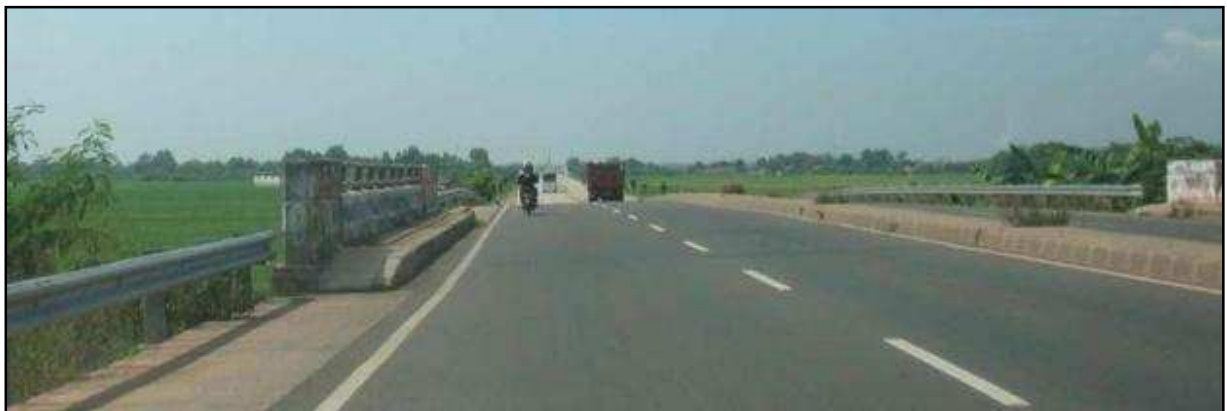
There is a gap between the guard rail and the bridge parapet

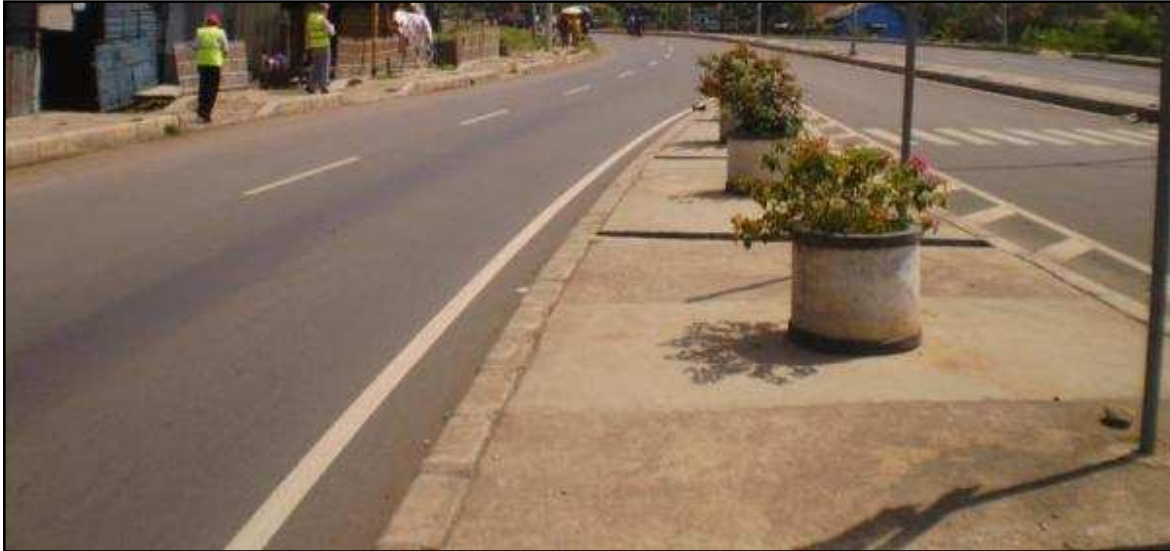
There is an un-continuous pedestrian crossing, see photograph below;

- **Complete road markings for pedestrian crossings**

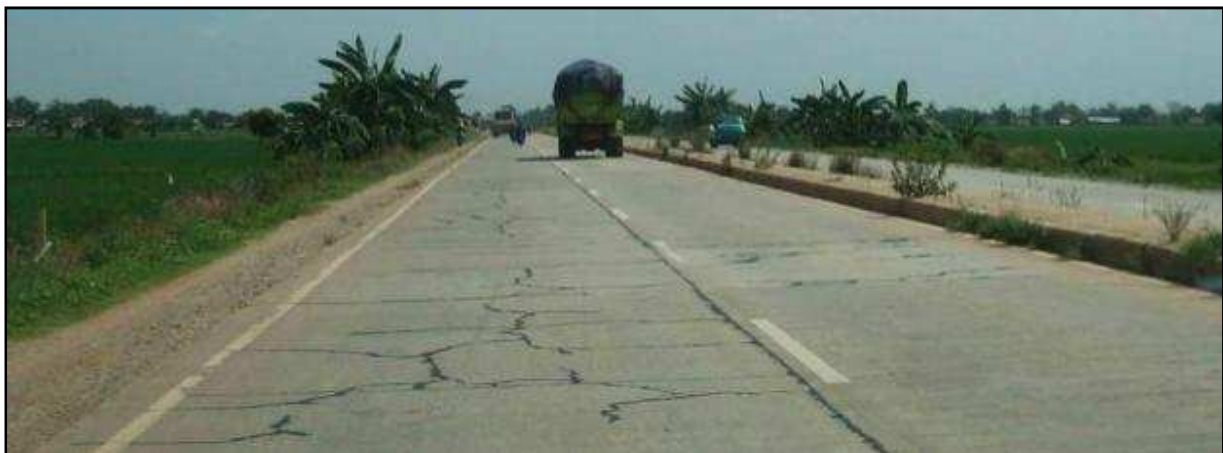
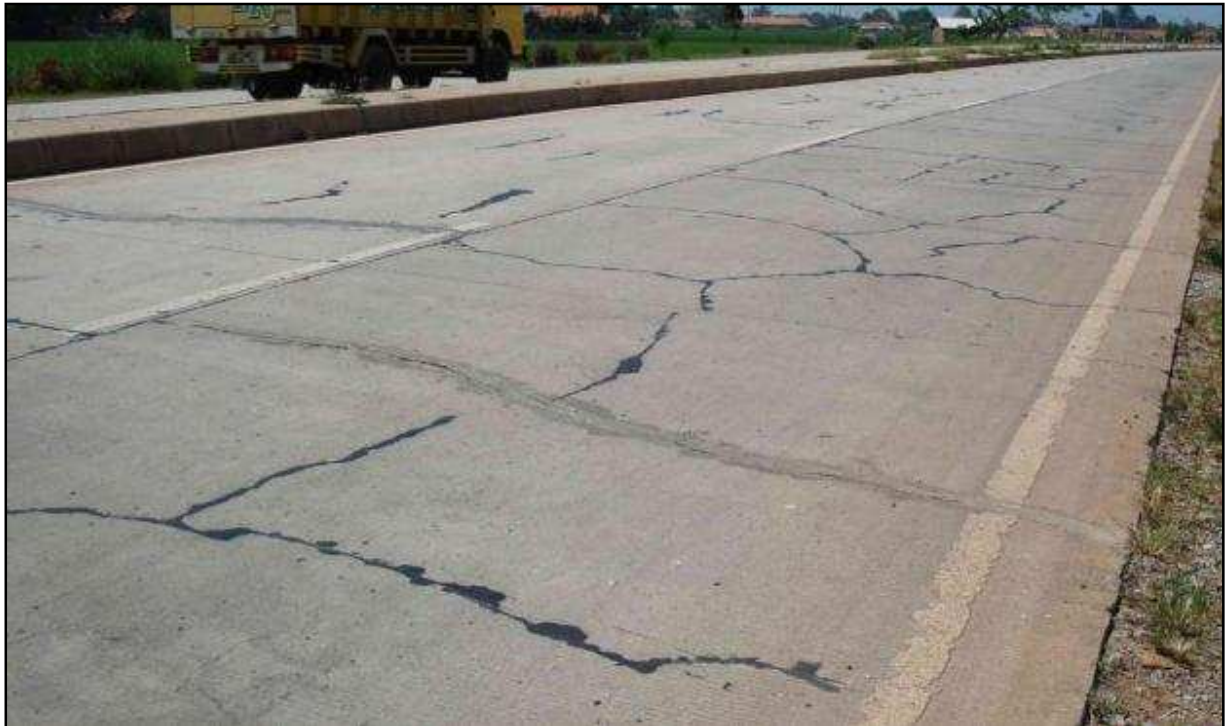
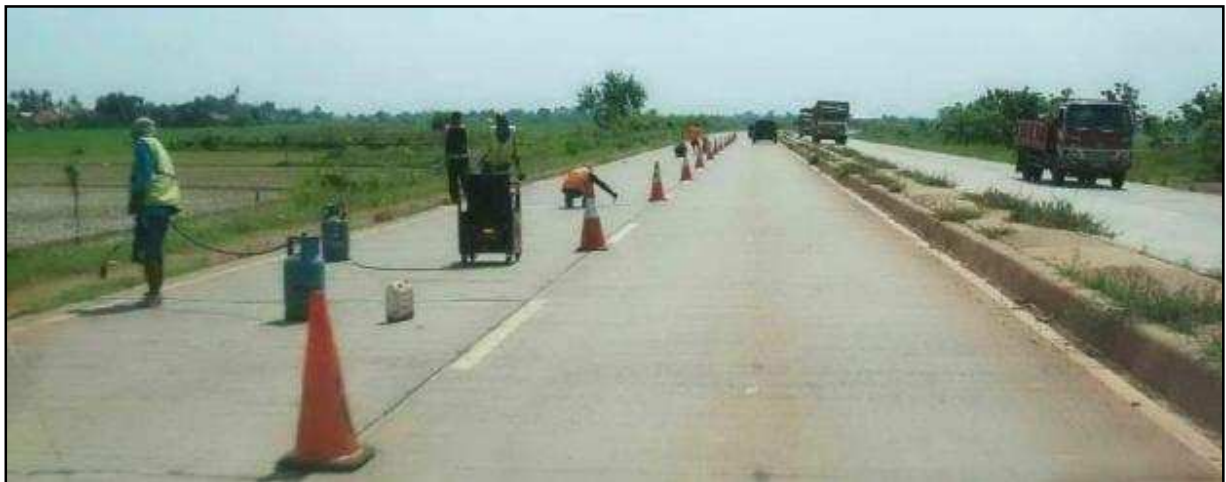
Many slabs of the new concrete pavement were completely cracked and some were being repaired already. This has serious safety implications particularly for motorcyclists. The subsequent road works pose hazards for all road users as well as the workers. See photos below

- **Review the reasons for the breakup of the concrete and whether related to design, construction or supervision**
- **Apply lessons learned to future projects with similar pavement**
- **Ensure repairs are permanent and will not have to be repeated throughout the life of the project**
