SEMARANG NORTHERN RING ROAD ROAD SAFETY AUDIT REPORT As Constructed

January 2011

Strategic Roads Infrastructure Project (SRIP)

SEMARANG NORTHERN RING ROAD ROAD SAFETY AUDIT REPORT As Constructed June 2010

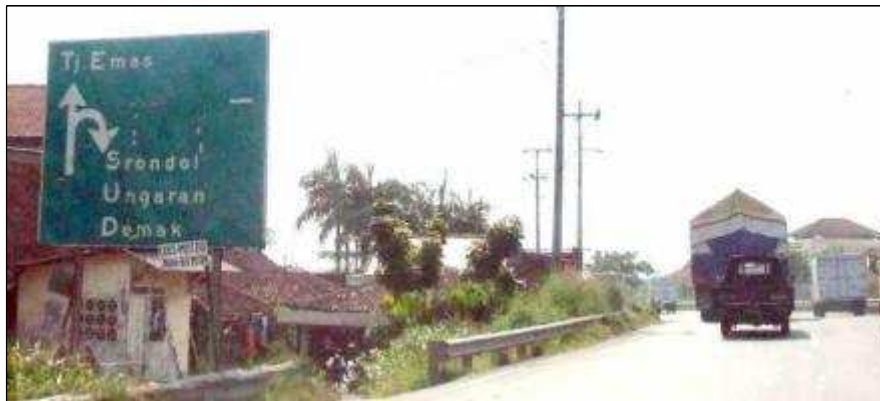
Old
Advance
Direction
Sign

- Review all signs and markings at U Turns
- Add new lane markings, arrows and large secondary direction signs at entrances to U turns. Ensure consistency of destination
- Improve the visibility of the standard advance warning signs using additional “Exclamation Sign”, see below or yellow backing board

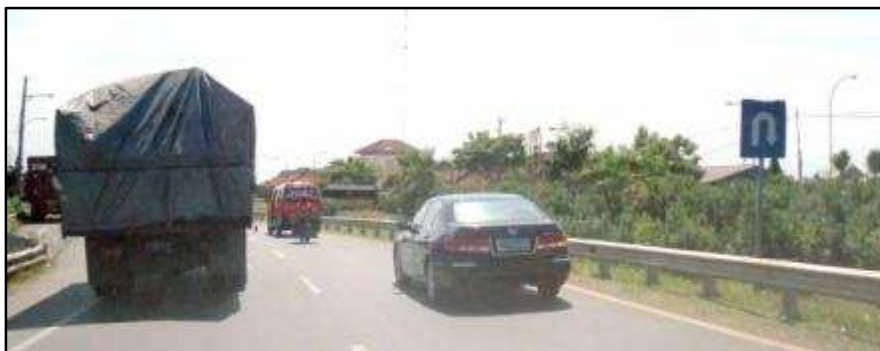
Standard
U Turn
Warning
Sign

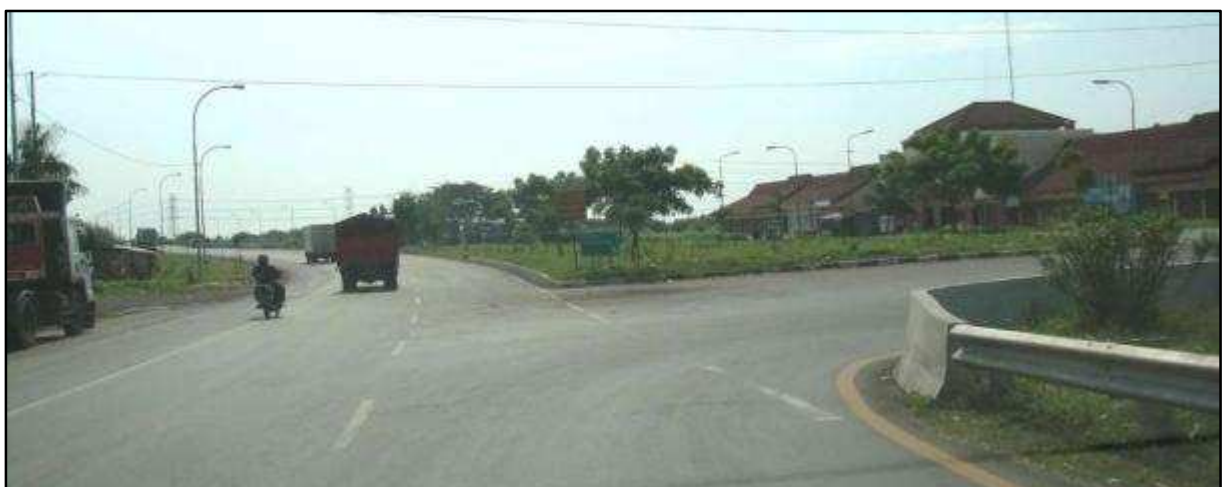
There are two major U turn facilities that are poorly signed - see photos below travelling northward from start of project. The road is the extension of a high speed toll-way and weaving and confusion needs to be minimized for safety's sake.

Unclear Signing & Markings at U Turn - Close Up Below

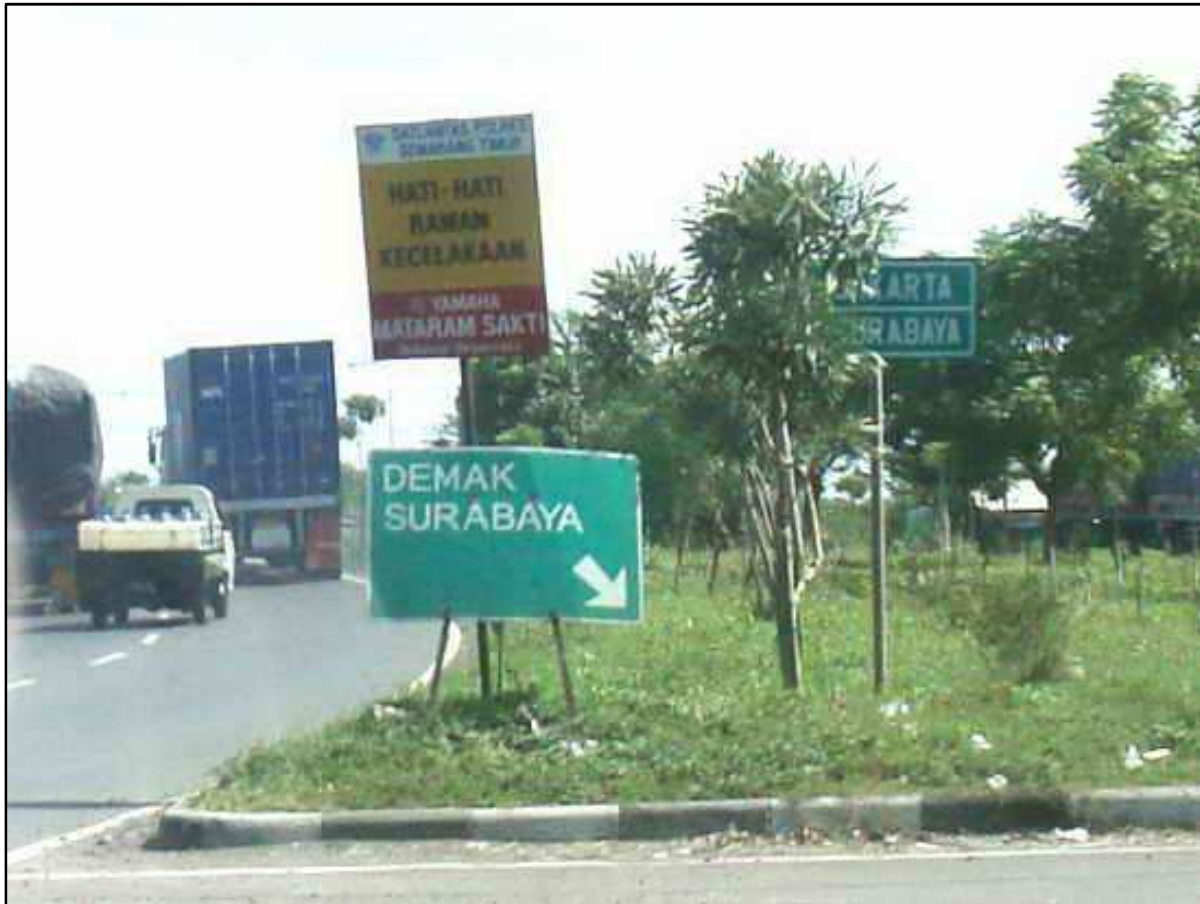
Very Poor Directional Signing at U Turn - Different Names from Advance Sign

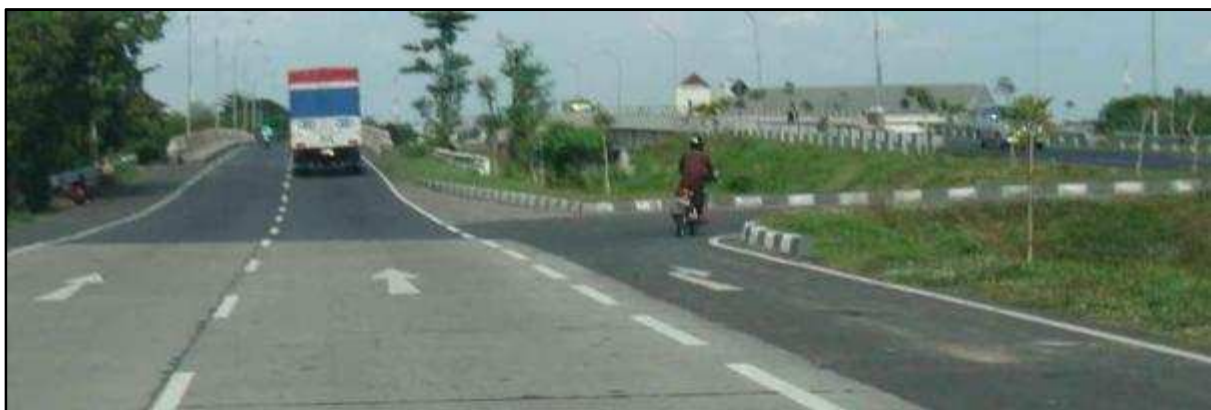
The Southbound facility is easier to see and understand for road users but could still be improved. It has clear lane markings, hatching and turning arrow but no reminder directional signing - see below

Clear Road Markings but Lack of Direction Sign

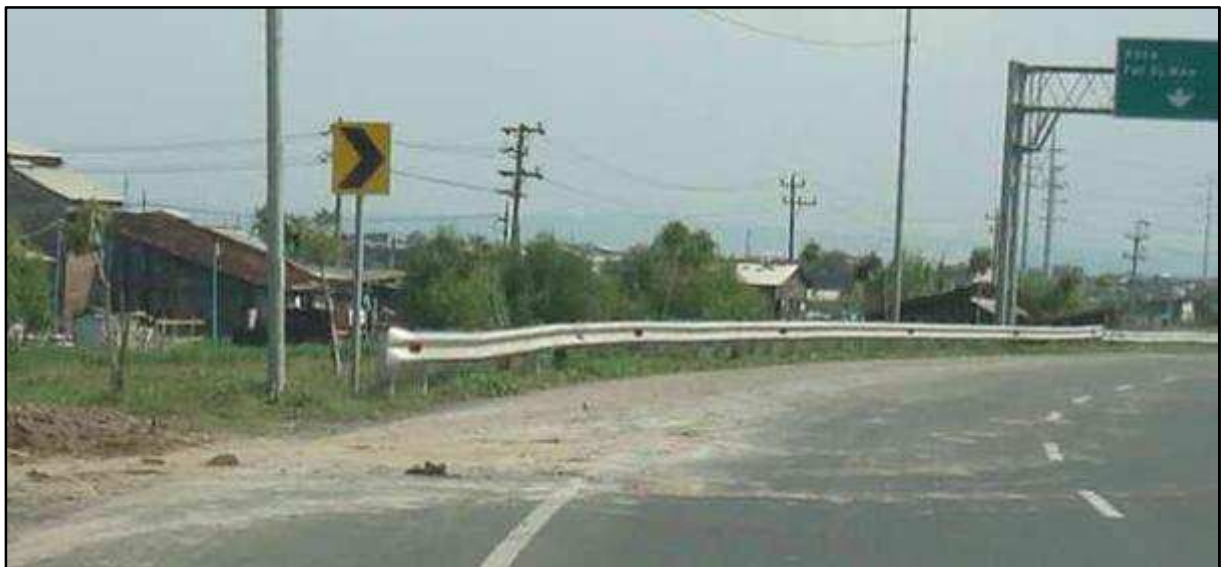
Several sections of guardrail have exposed ends that could increase severity of injuries in crashes.

Exposed but Protected end of Guardrail at start of bend

- All ends buried or protected as per standard.
- Guardrails do not start at beginning of bend - but in advance
- All water hazards protected.
- All bridge parapets are connected to guard rails, as shown belows;

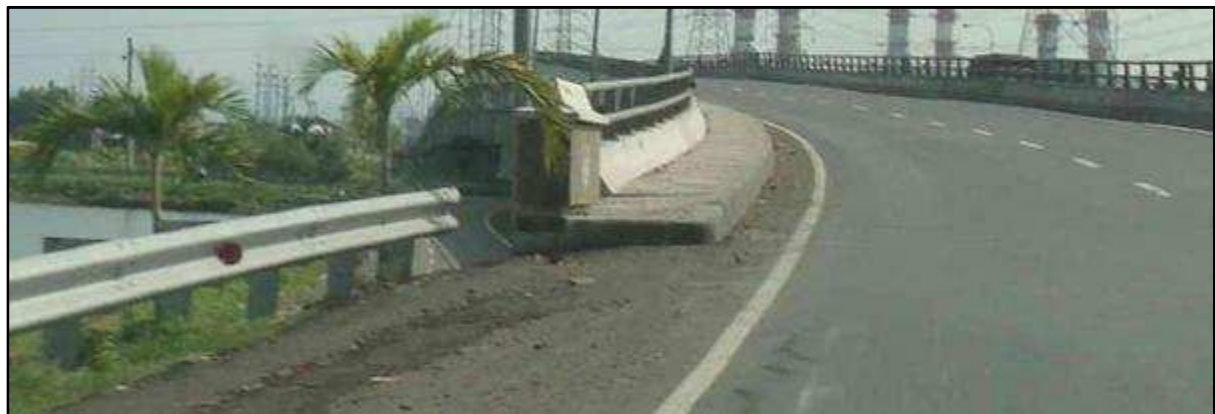
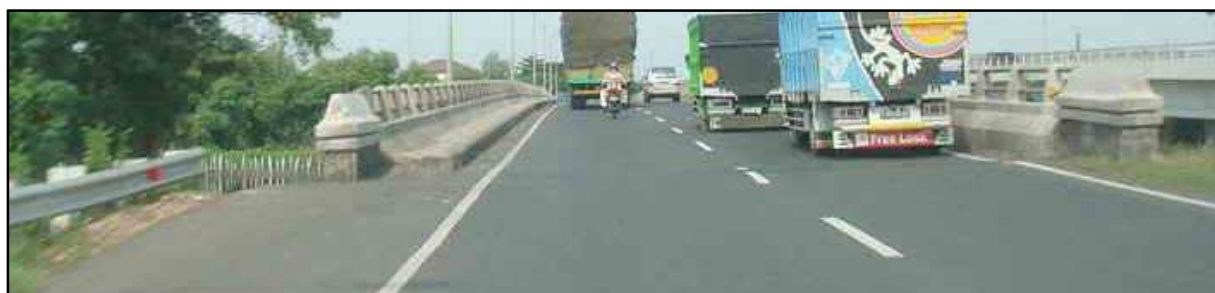
Connections with bridge parapets can also be made more severe by poor guard rail design. Vehicles that hit the guardrails shown below will be directed to a serious collision with the parapet

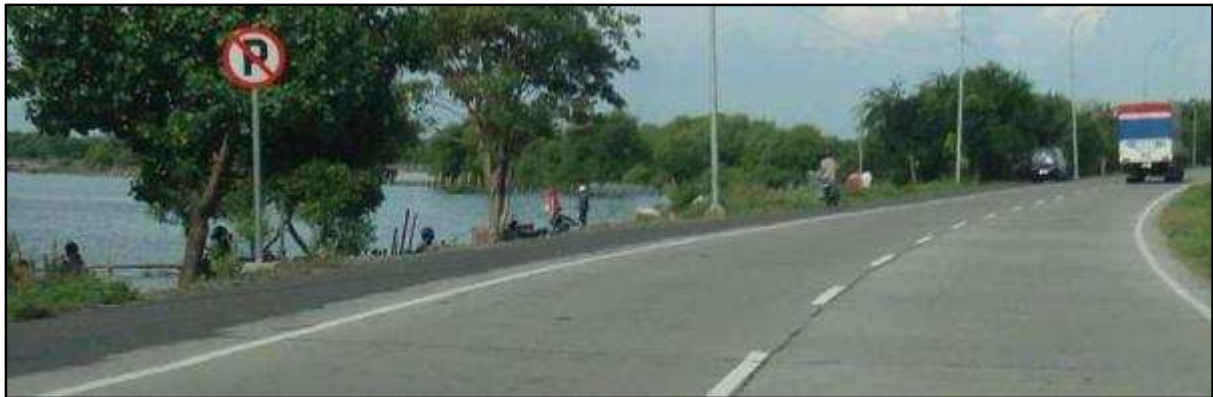
Guardrails are required at water hazards, particularly on high speed roads, but are missing at location shown below:

Missing Guard Rails at Lake

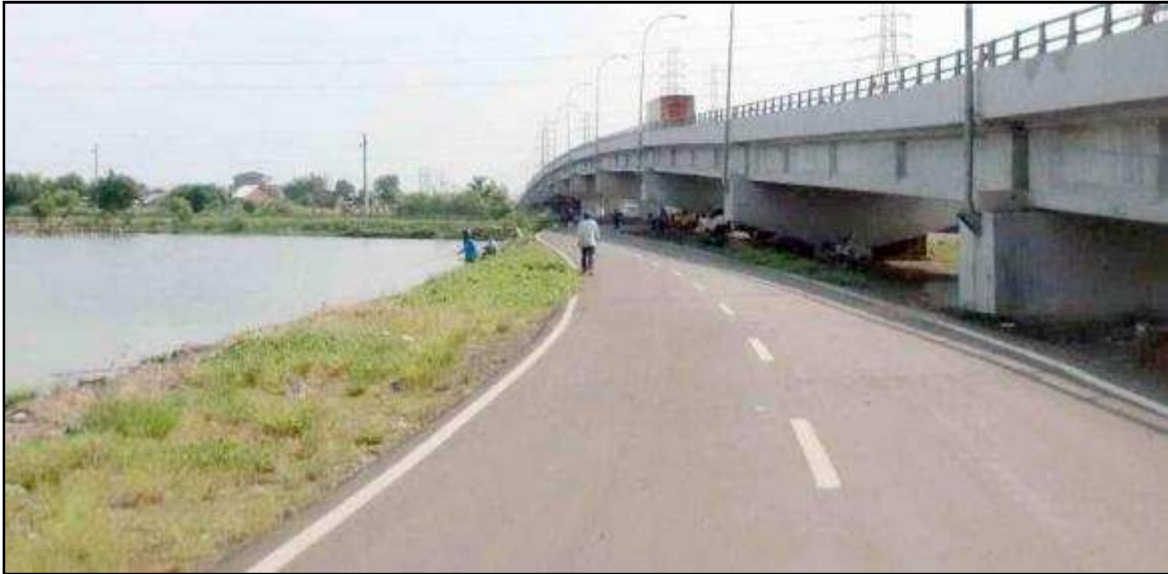
Local Road - Two Way - Lack of Guideposts or Guard Rail

- **Carry out review of exits and local roads.**
- **Improve the directions signs and add reminders.**
- **Increase numbers guideposts and lengths of guardrail at waterside.**
- **Protect exposed ends of guardrail.**

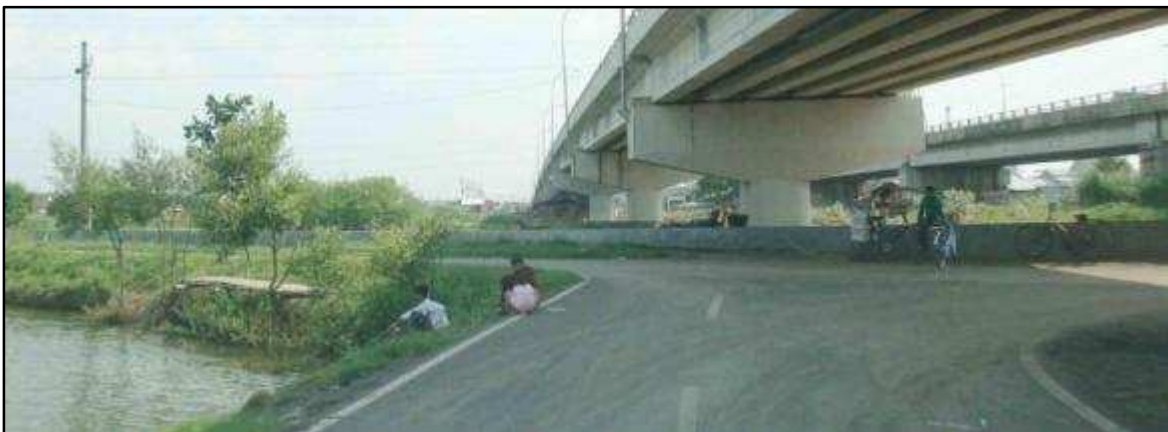
Local Road - Lack of Delineation & Signs

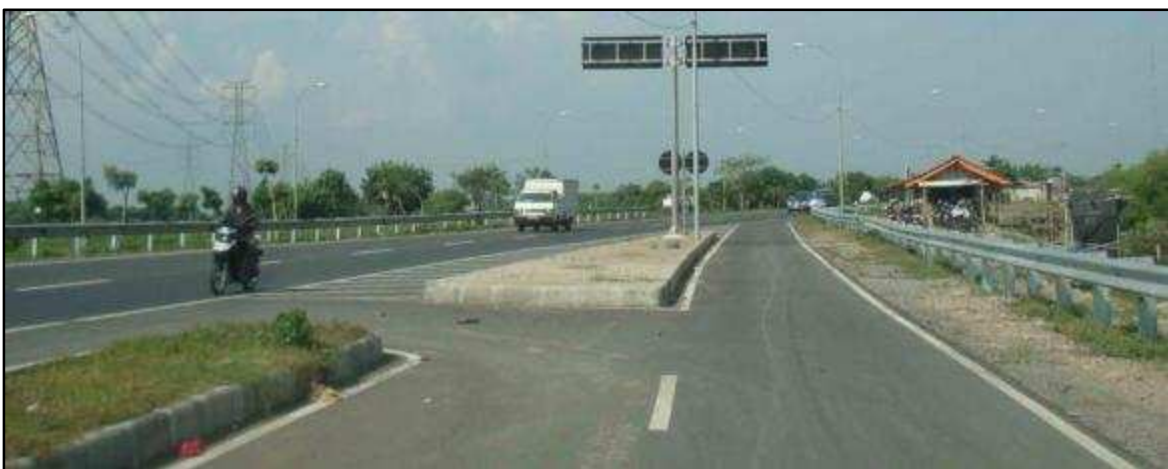
Lack of Arrows & Signs for Return to Highway

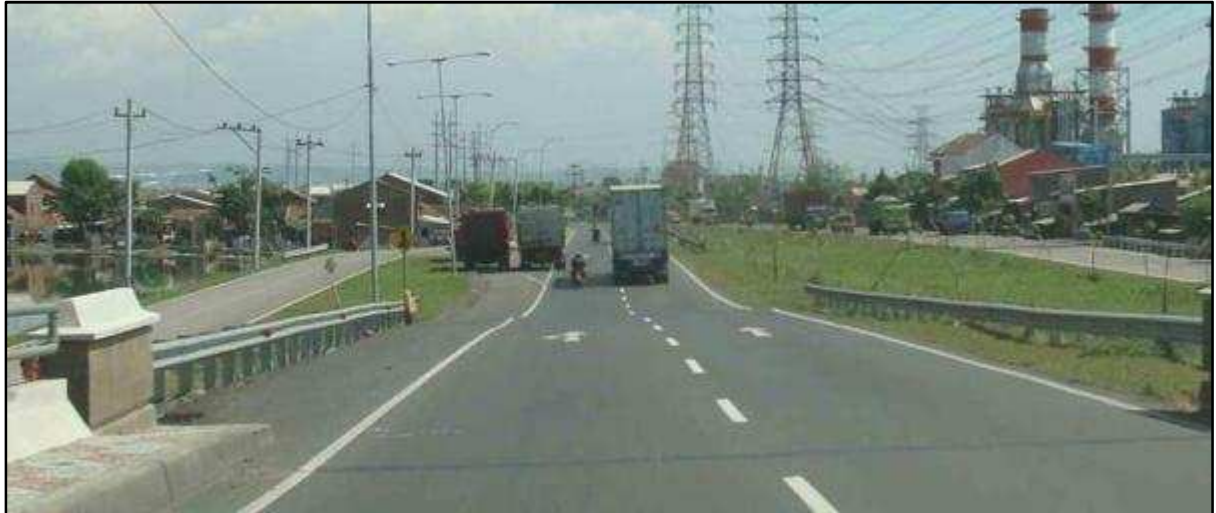
Exit to Local Road Unsigned & Hidden by Parked Trucks

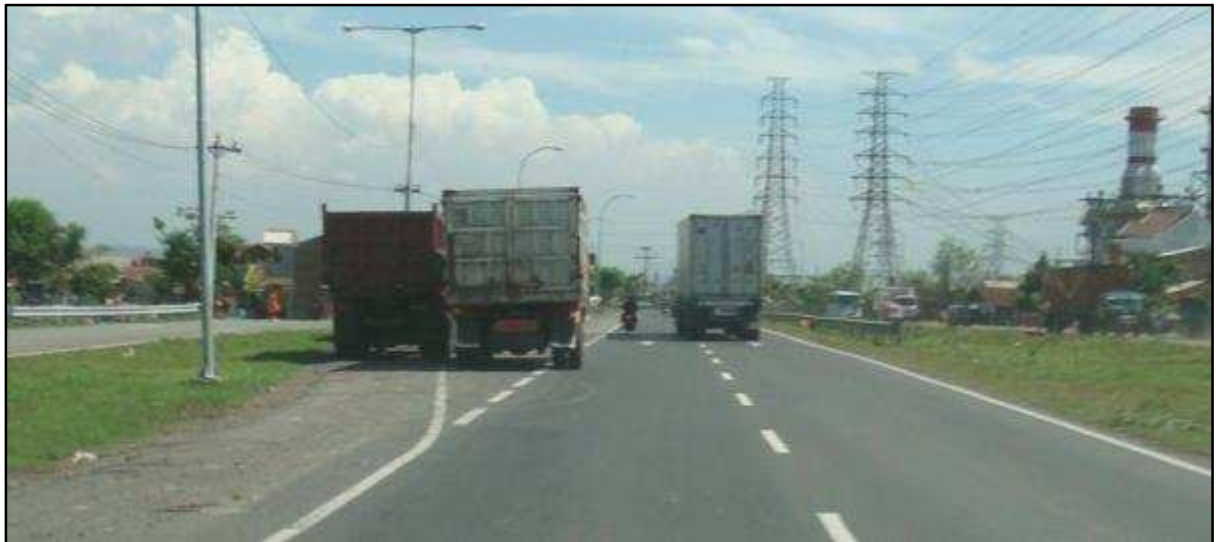
Exit to Local Road Still Hidden & Blocked

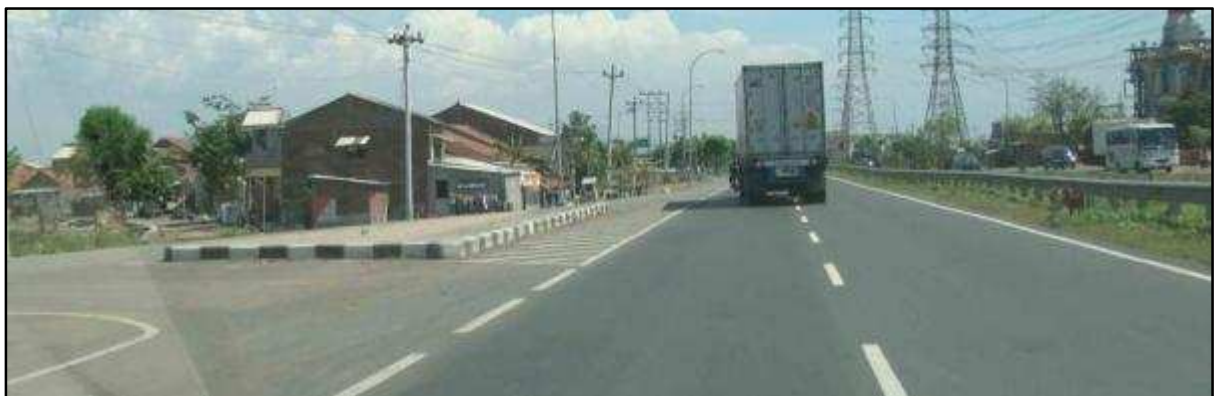
Exit to Local Road Unsigned

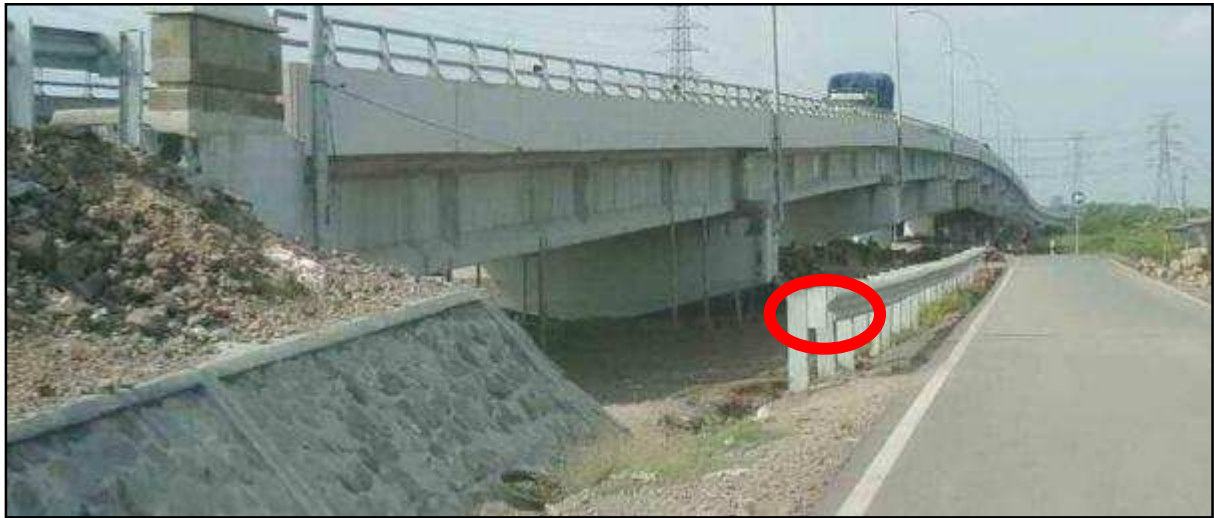
Exposed End of Guard Rail & Poor Signing, Circled (see below)

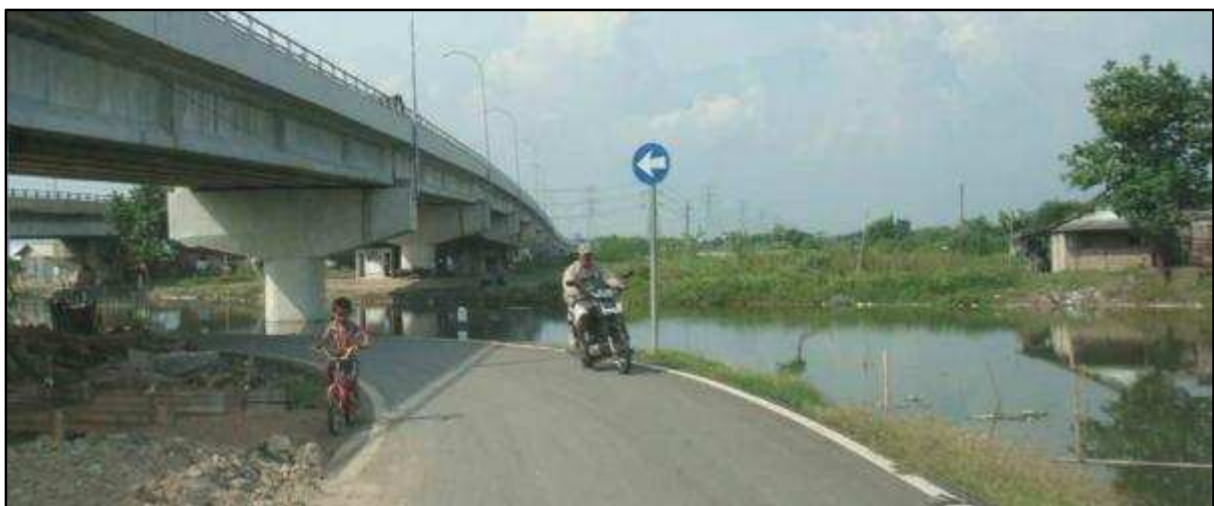
Poor Signing & Inadequate Delineation or Protection at Water & Below

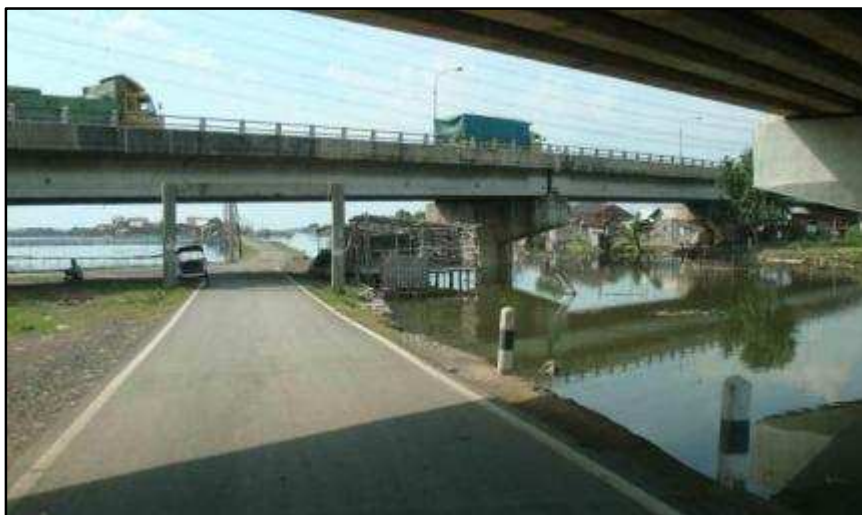
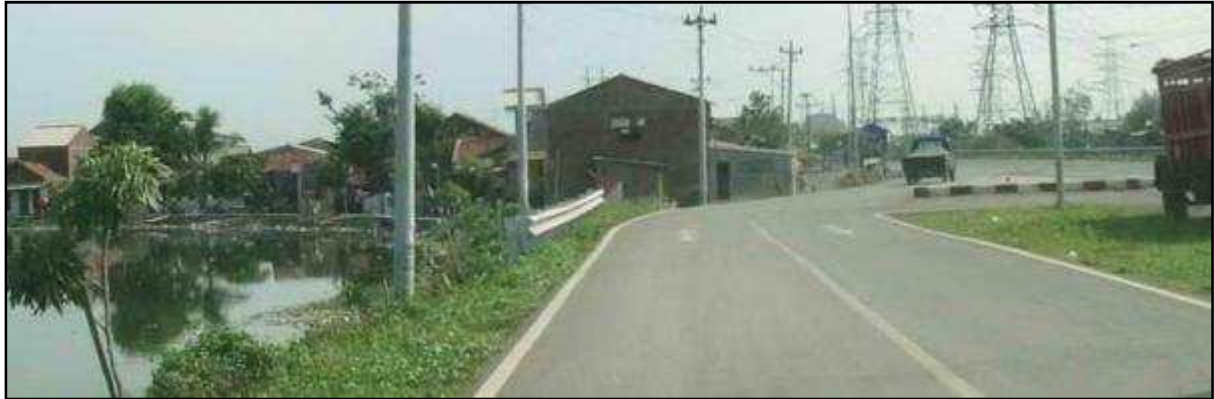
Unprotected Water Hazard, Exposed End of Guardrail & Lack of Signs
