**KARANG AMPEL - CIREBON
ROAD SAFETY AUDIT REPORT
As Constructed**

THE PROJECT MANAGEMENT UNIT
STRATEGIC ROADS INFRASTRUCTURE PROJECT
Under IBRD Loan 4834 / 7786 ID

PACKAGE KARANG AMPEL - CIREBON ROAD SAFETY AUDIT REPORT Existing Road Stage - As Constructed June 2010

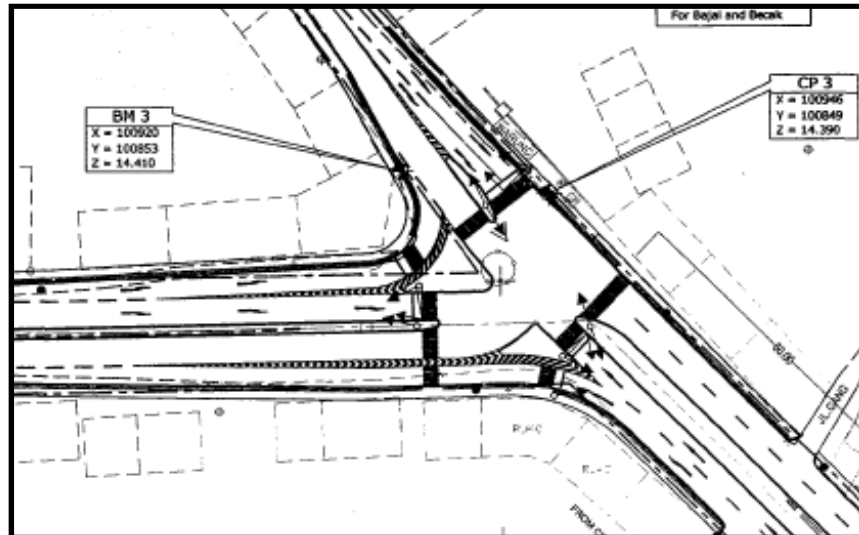
Intersection KRCR 01 Sta.0+000

Phase A	Phase B	Phase C
G = 17 seconds G + I = 23 seconds (G + I)/C = 38.3 %	G = 15 seconds G + I = 21 seconds (G + I)/C = 35.0 %	G = 10 seconds G + I = 126 seconds (G + I)/C = 28.7 %

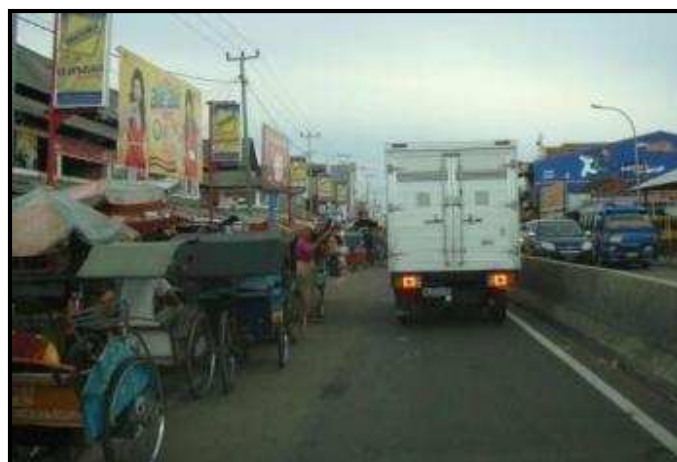
**Busy Market
Section of
Project near
northern end in
Karang Ampel**

The proposed design included new signal equipment, islands, footways, pedestrian barriers, but this was not implemented. The junction is still very unsafe for pedestrians and much of the signal equipment is not working or damaged, see photos below:

- Add rumble bars to all approaches
- Ensure all broken signal equipment repaired promptly
- Upgrade main signal head on each approach to large high visibility specification

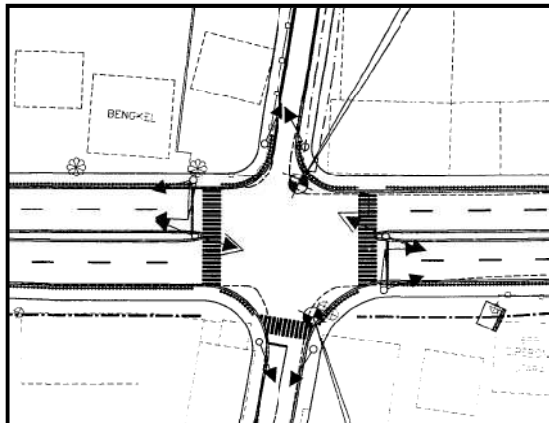
Proposed Signal Design at Junction at Sta 27+000

Phase A		Phase B	
G = 96 seconds G + I = 102 seconds (G + I)/C = 81.6 %		G = 17 seconds G + I = 23 seconds (G + I)/C = 18.4 %

Junction at Sta 27+000 Still Un signalized

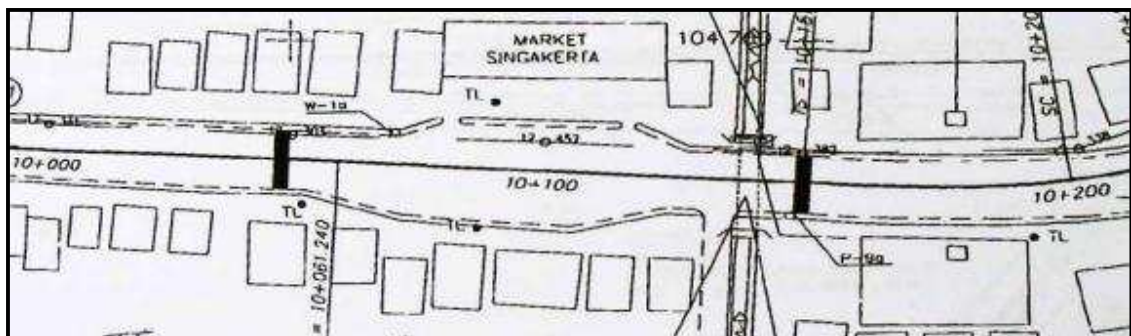
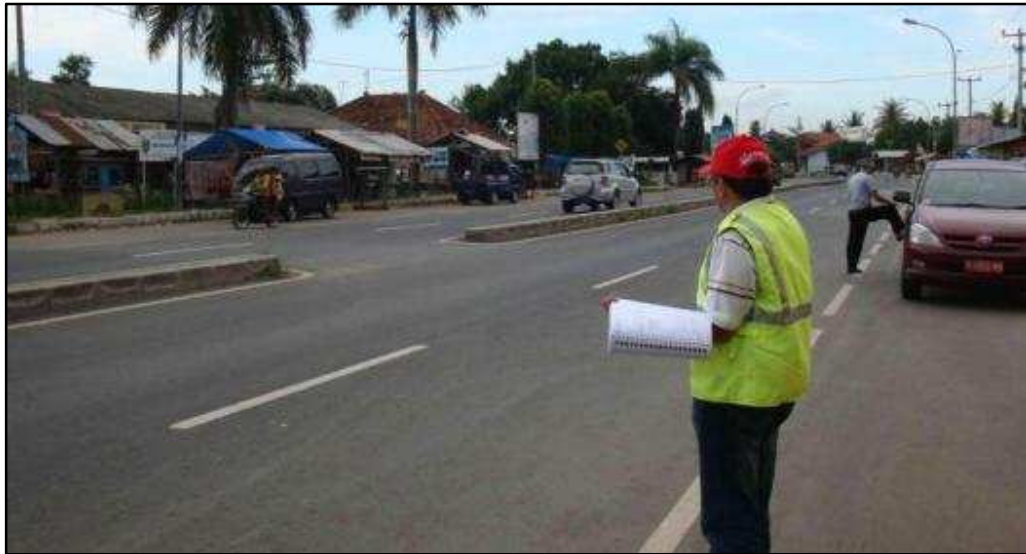
The only one set of bus bays were installed at the market Sta.10+100, see plan & photo below

- **Review need for bus stops, parking and loading areas and design and install appropriate facilities**
