**KARAWANG BYPASS
ROAD SAFETY AUDIT REPORT
As Constructed**

January 2011

THE PROJECT MANAGEMENT UNIT
STRATEGIC ROADS INFRASTRUCTURE PROJECT
Under IBRD Loan 4834 / 7786 ID

PACKAGE KARAWANG BYPASS ROAD SAFETY AUDIT REPORT As Constructed June 2010

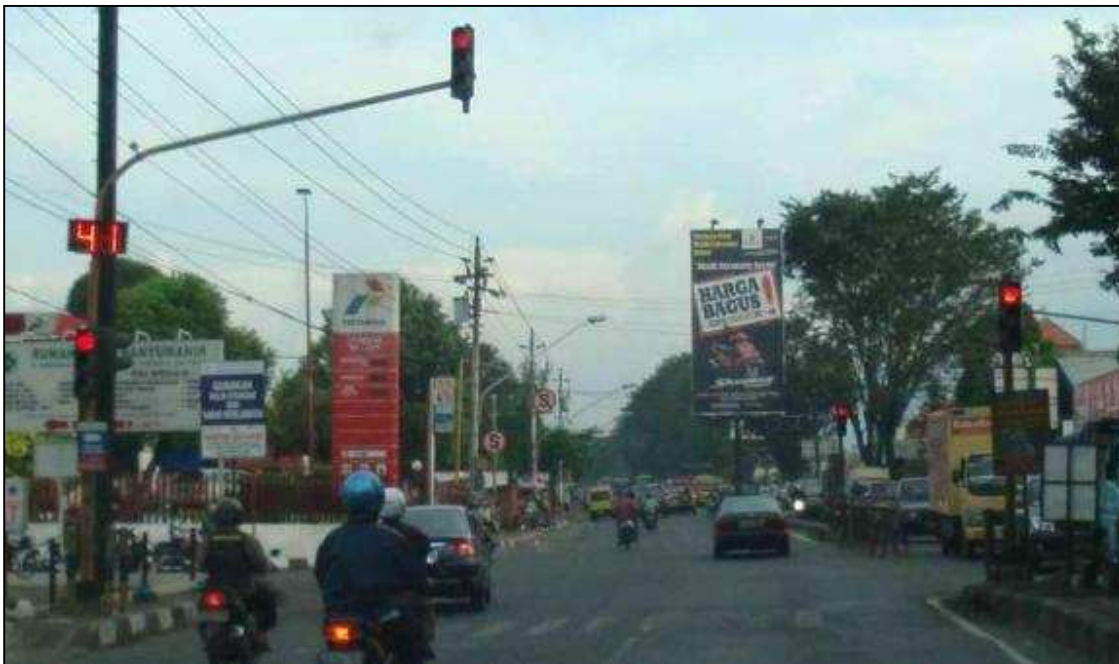
Good locations of signal lights with bright LEDs - Semarang Bawen

- Add rumble bars to all approaches
- Ensure all broken signal equipment repaired promptly
- Upgrade main signal head on each approach to large high visibility specification, (see photo below)
